Cultural Landscape Report, Treatment, and Management Plan for Branch Brook Park

Newark, New Jersey

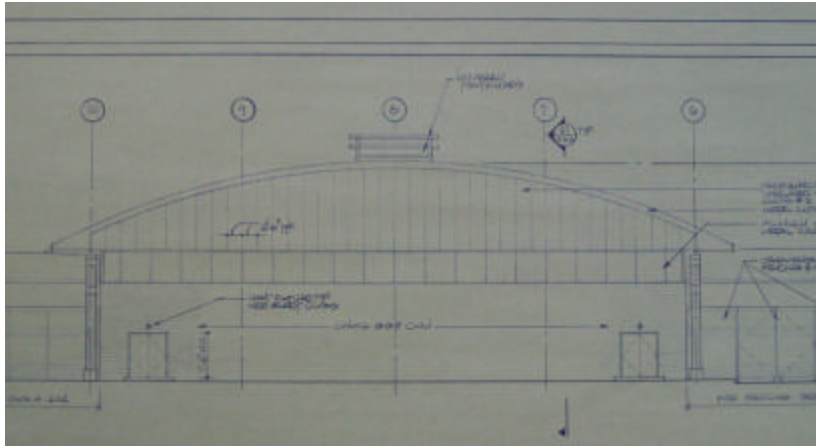
Original Drawing 1
South elevation of the roller rink

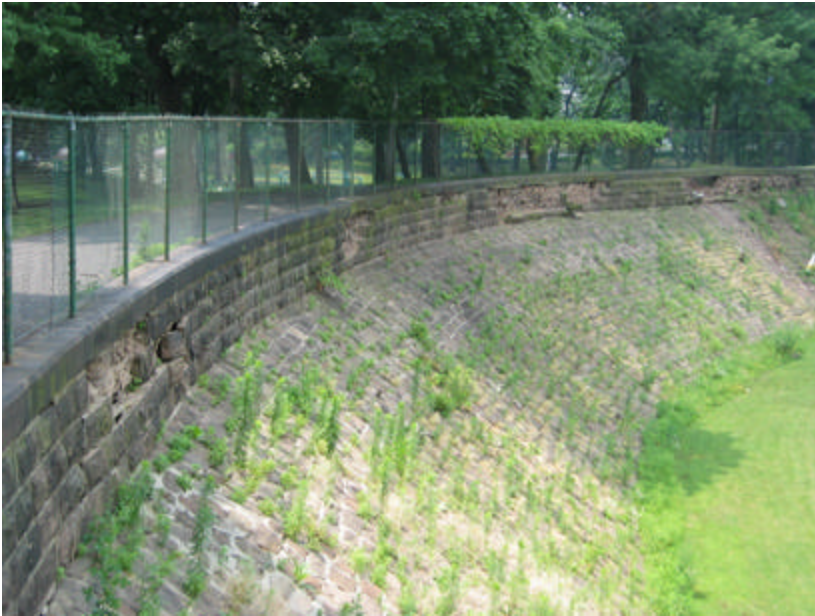
Photo 6
Areas of spalled and missing stone along the wall at the top of the reservoir; note that some areas of spalled brownstone are over 40' – 0" in length.

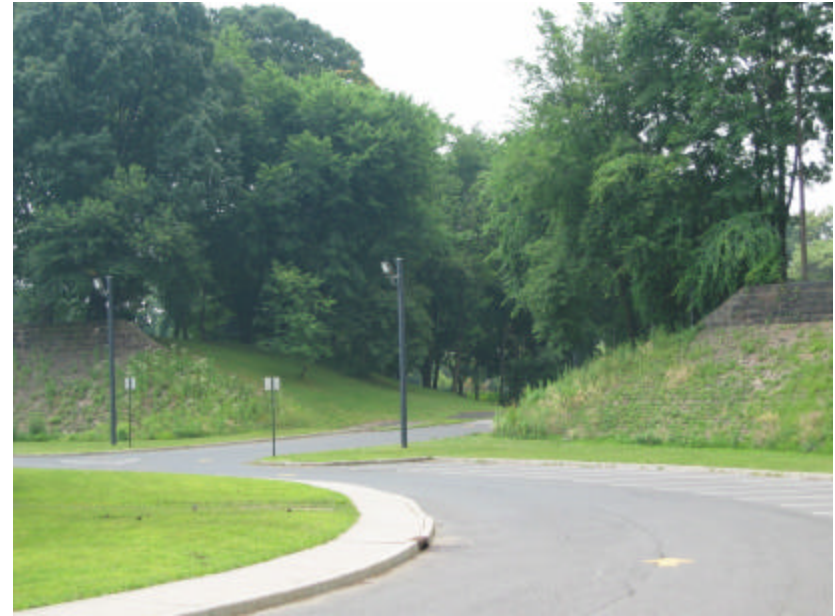
Photo 7
A cut was made in the wall so that a road and parking lot could be built.

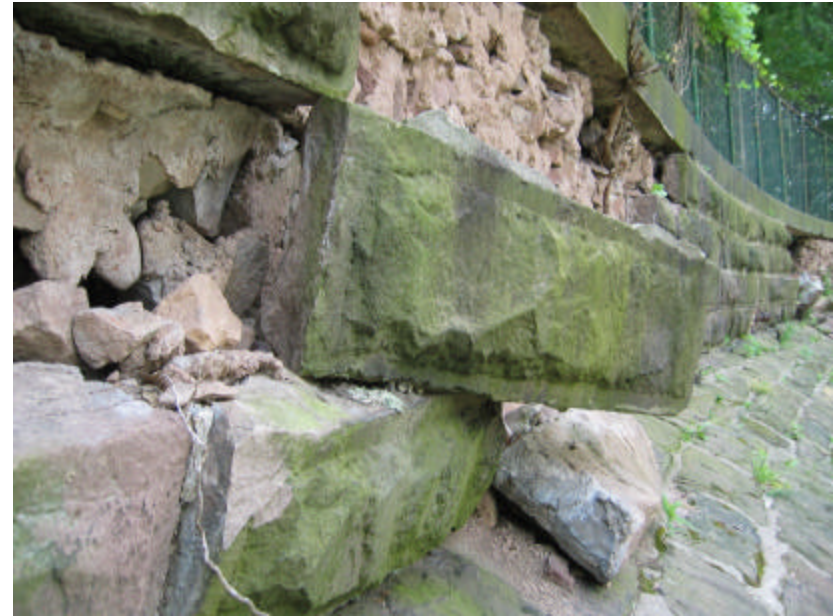
Photo 9
Spalled and missing stone from the wall; note that there is a significant amount of stone missing from this area and the block in the photograph is ready to fall.

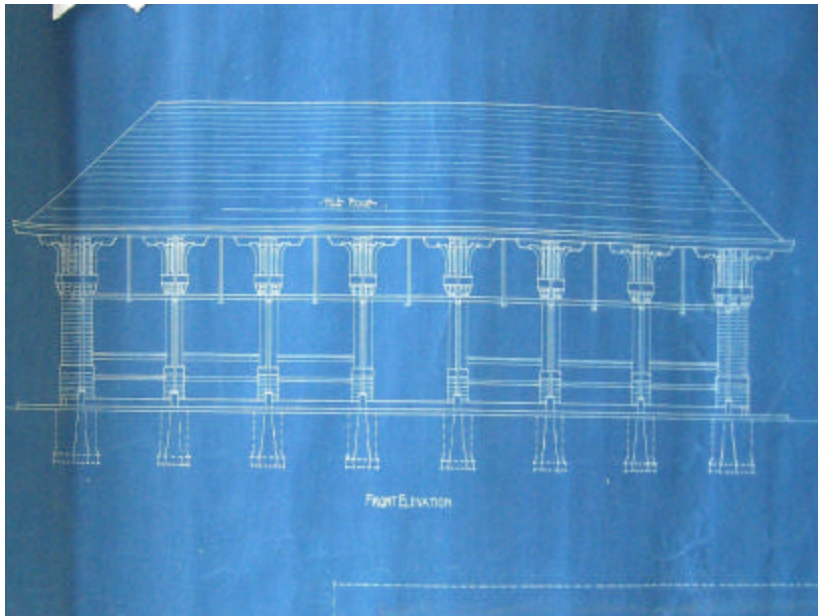
Original Drawing 3
The front elevation of the Sand Court Shelter; note that originally there were benches on the interior.

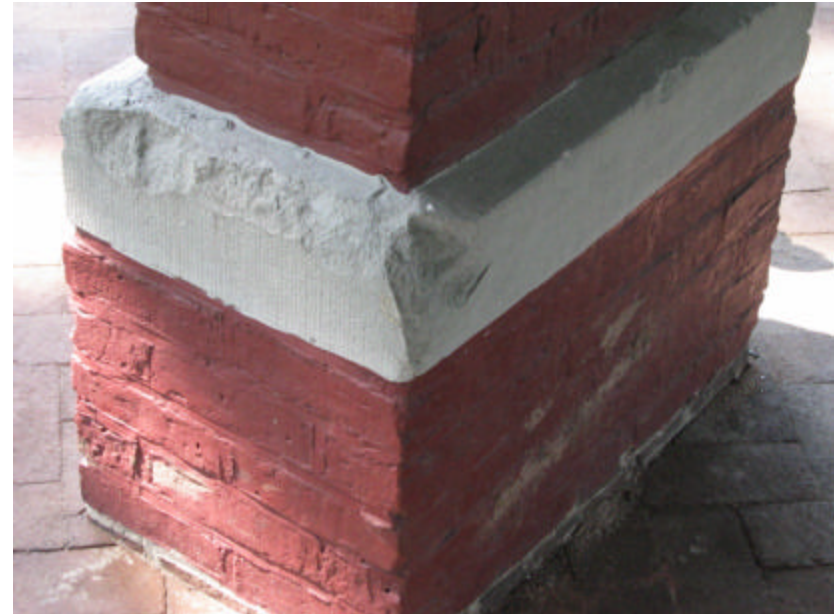
Photo 16
Significant chipping and wear to one of the limestone base caps.

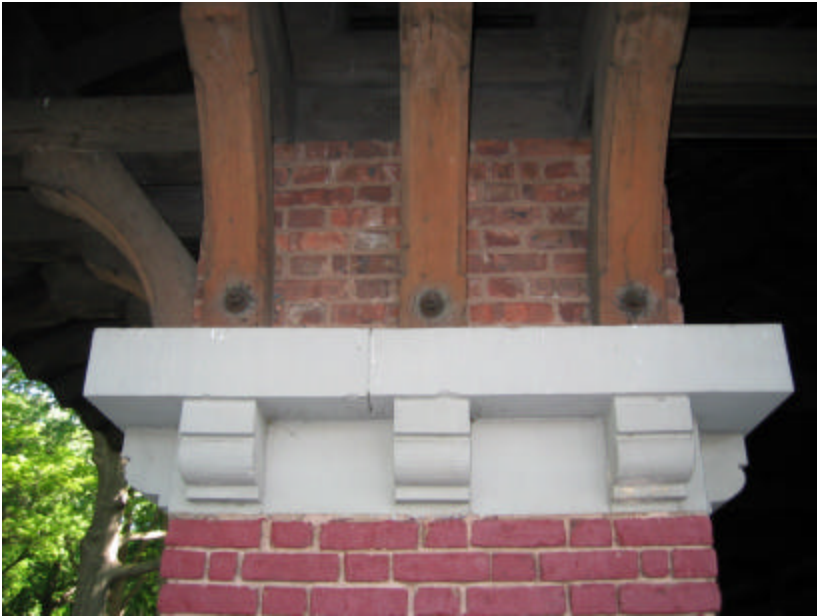
Photo 17
The limestone block and brackets above one of the "L" columns; note the staining and cracking of the wooden brackets.

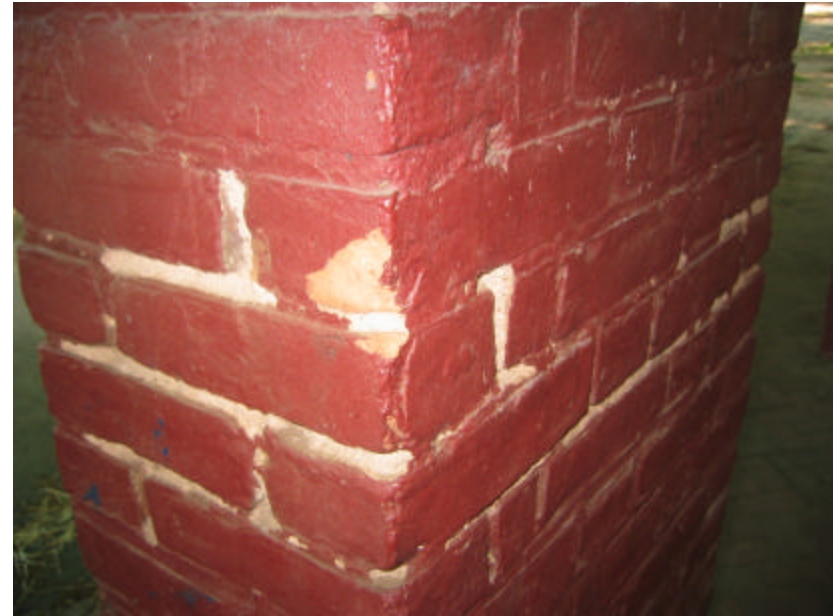
Photo 18
Typical chipping on the corner of the columns.

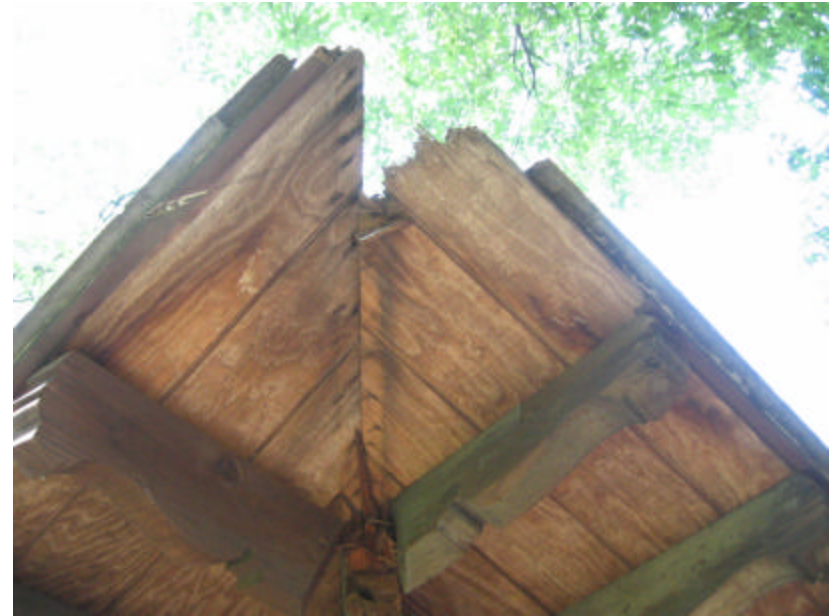
Photo 22
Damage to eaves and roofing; note that one of the eave supports is missing.

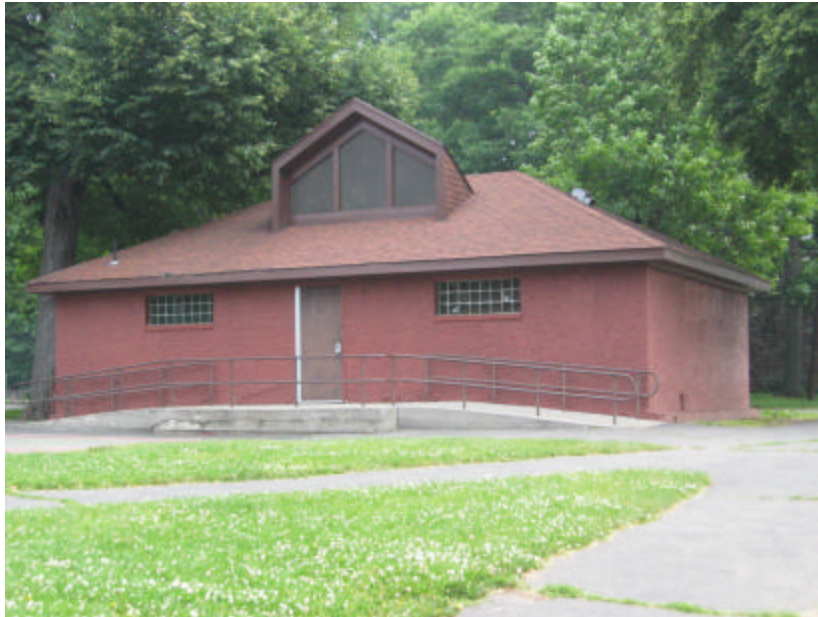
Photo 23
Overall view of the main façade of the field house; note the large skylight and glass block windows.

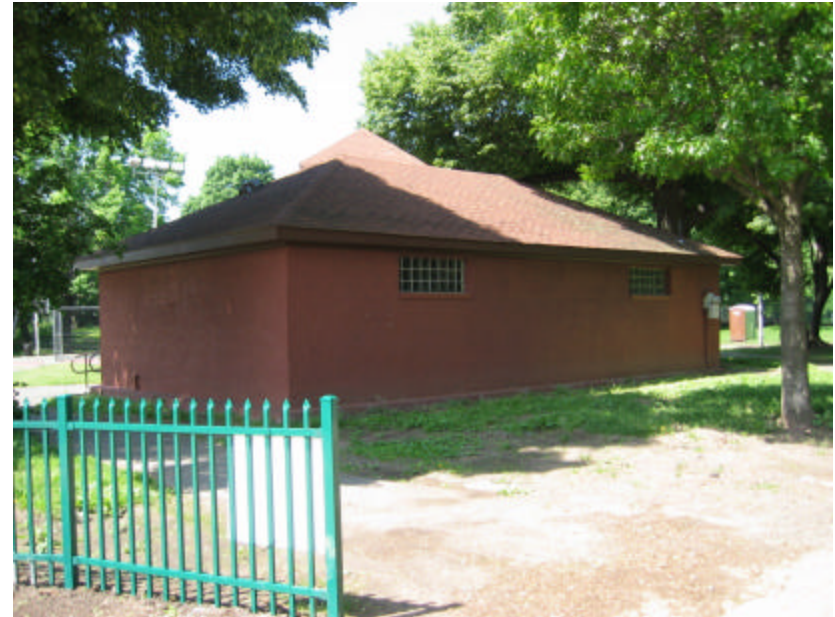
Photo 24
The field house, rear elevation; note that the stucco and roof are in good condition.

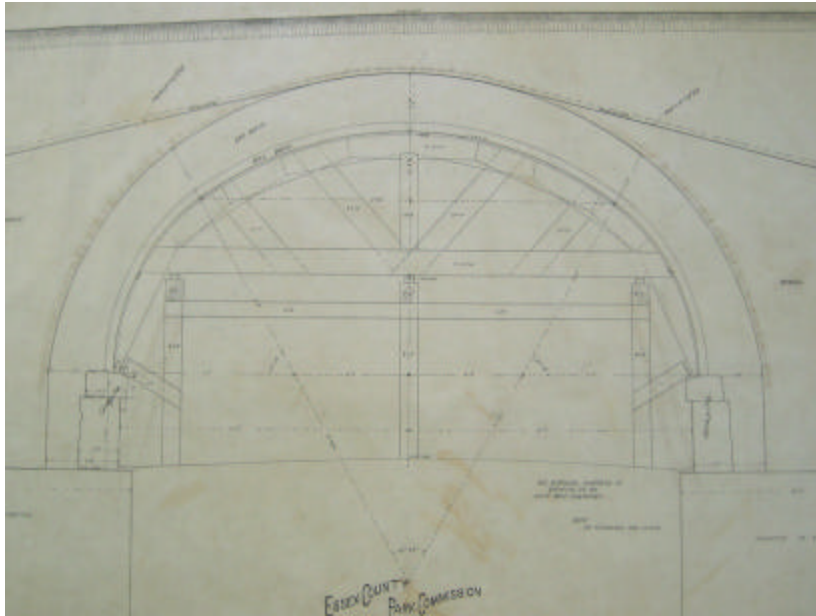
Original Drawing 7
A drawing of the subway showing the shoring used for construction.

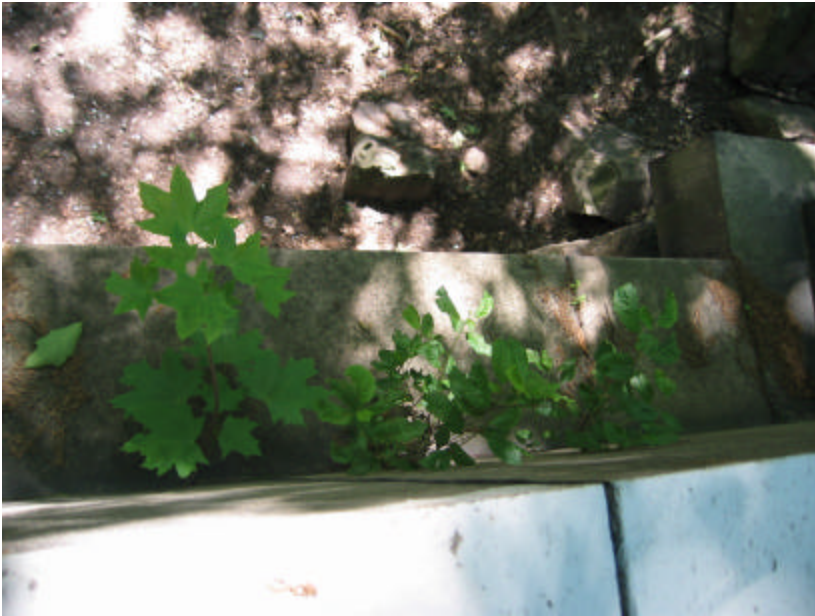
Photo 34
Plants growing out of the cracks in the lintel course below the railing.

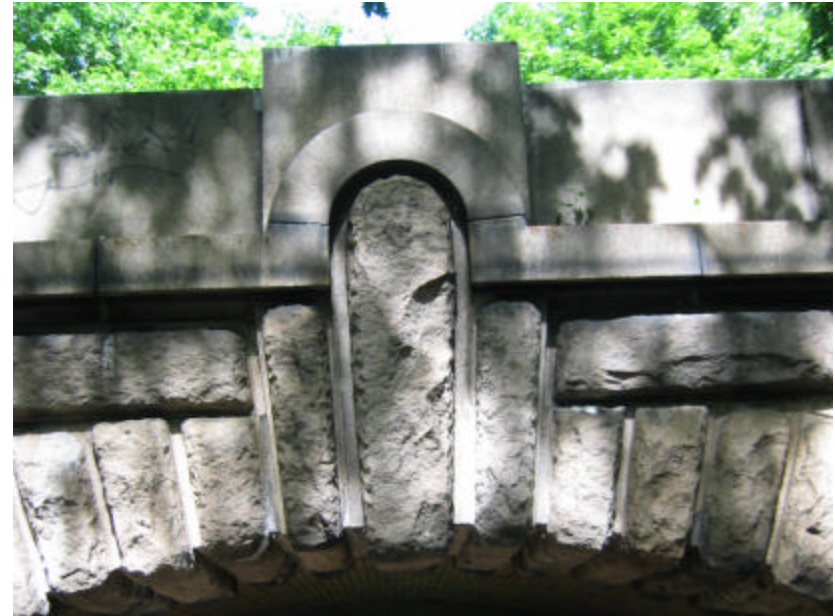
Photo 35
Close-up of keystone on the east archway; note the quarry-faced finish of the stone.

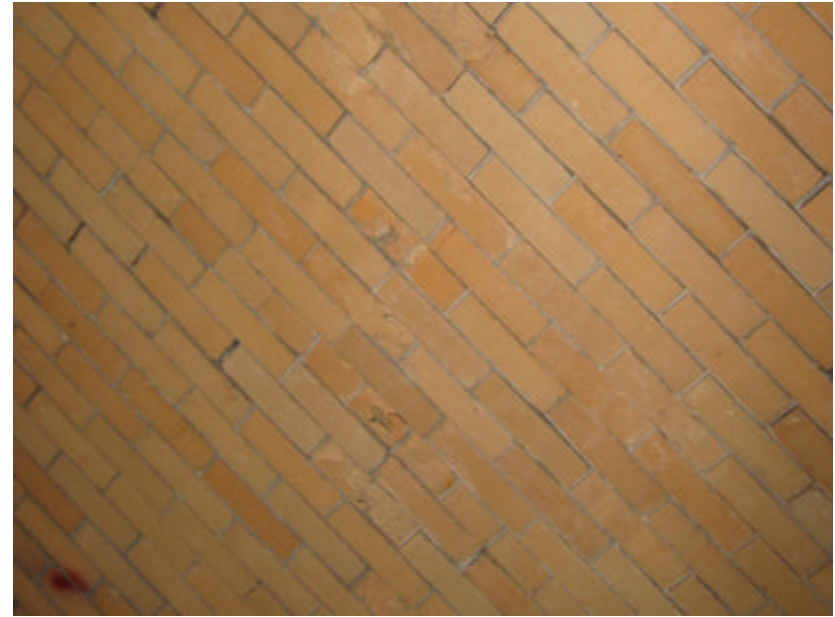
Photo 37
The effects of freeze-thaw on bricks; note the face of some bricks has spalled off and there is loose or missing mortar around most of the brick joints.

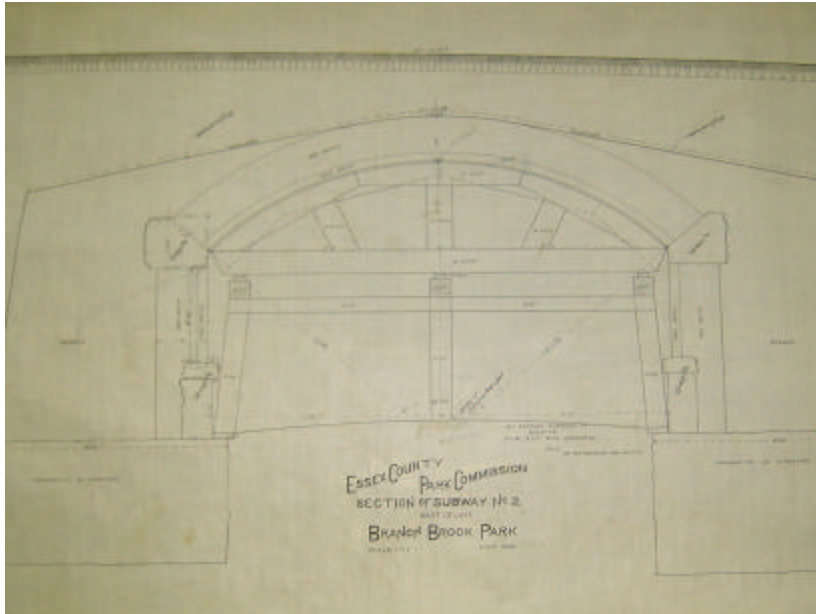
Original Drawing 8
This drawing provides details about the shoring used for construction and basic materials.

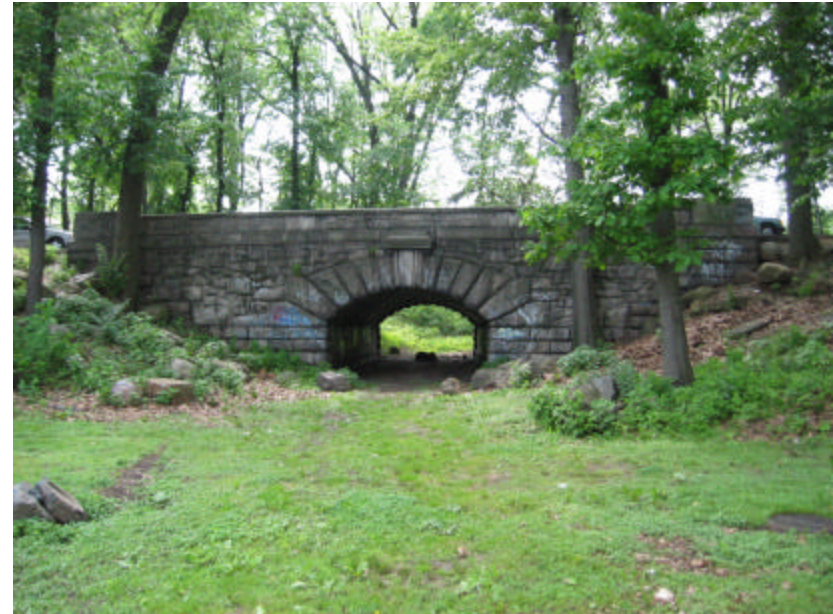
Photo 39
Subway 2 view to the west; note the segmental arch construction and the rustic finish on all the granite stonework.

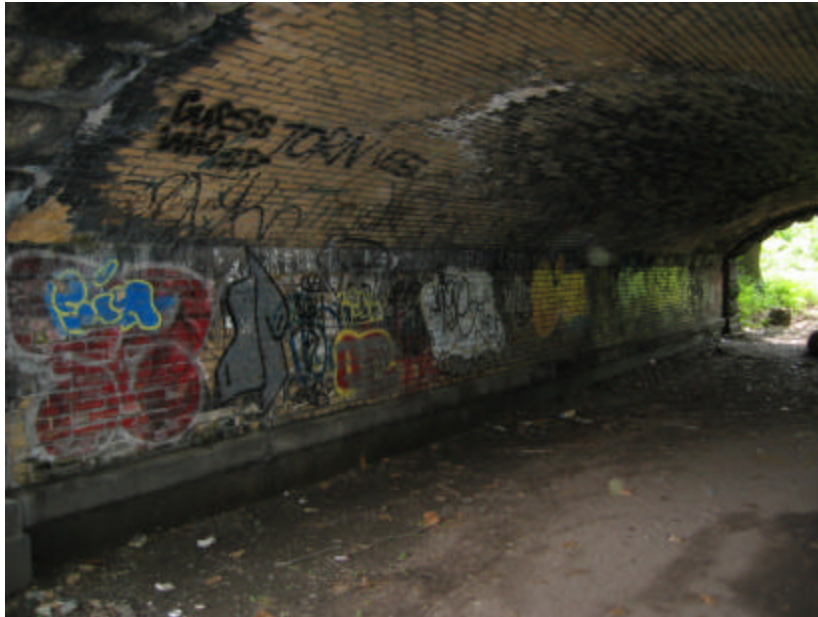
Photo 40
Interior of Subway 2; note the dirt floor and the excessive amount of graffiti and efflorescence.

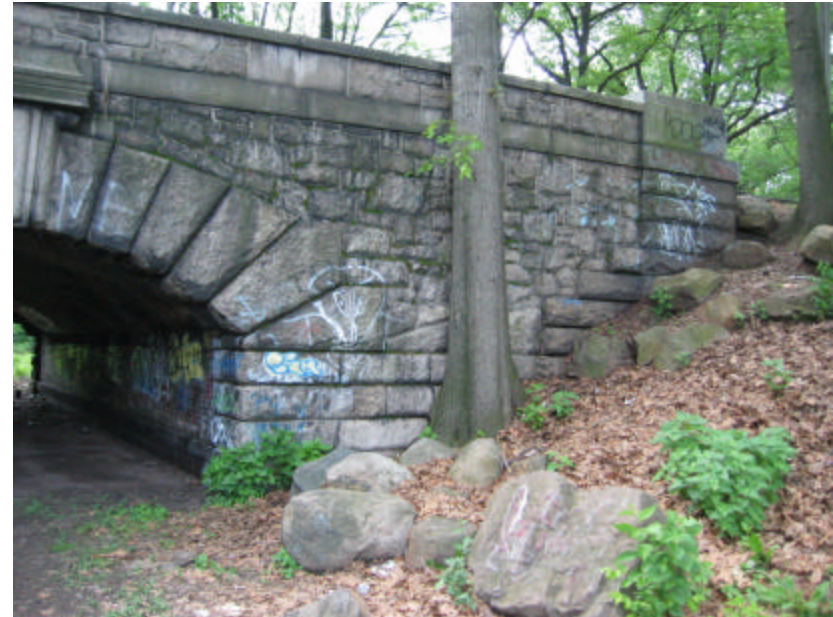
Photo 41
Quarry-faced finishes on the granite; note the broken ashlar pattern of the granite stonework on the vertical face of the underpass.

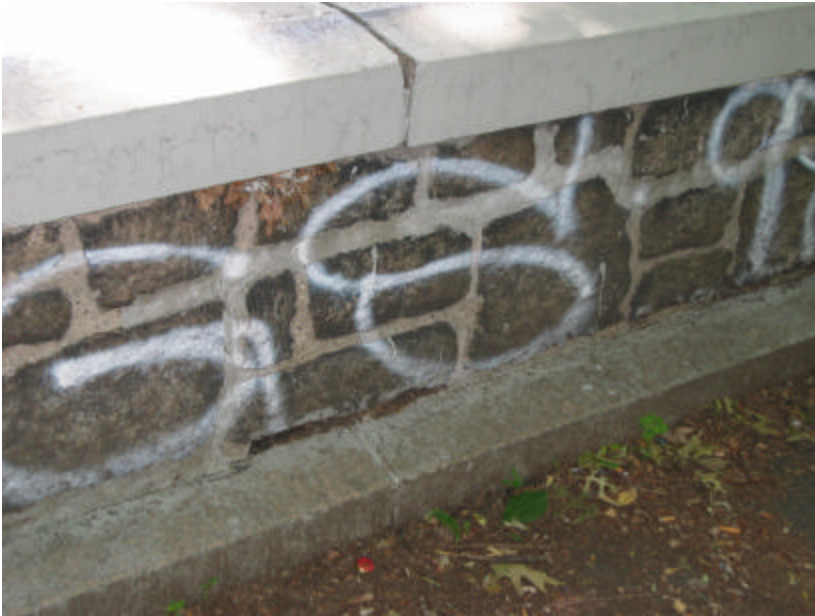
Photo 42
Detail of railing on the east side of Subway 2; note the cracking paint and open mortar joints of the railing and coping stones.

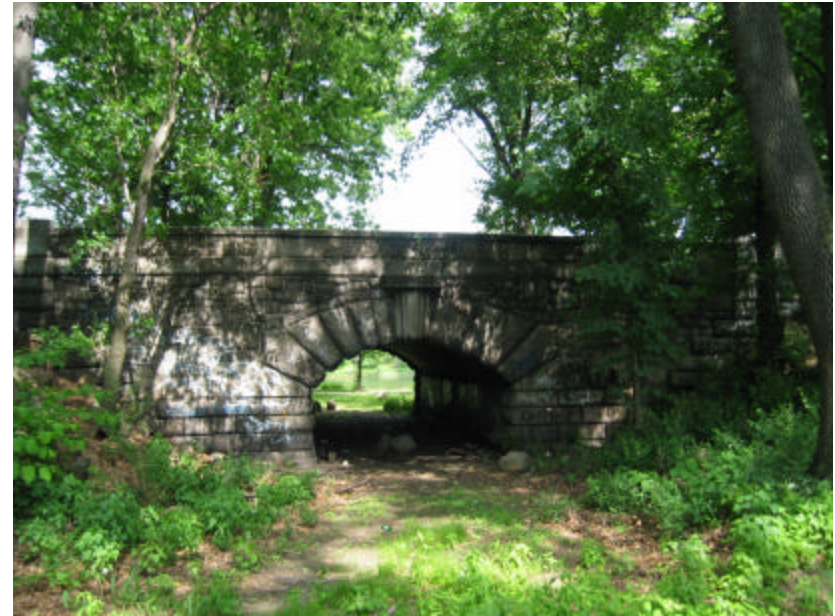
Photo 43
View of west side of Subway 2; note the deterioration of the surrounding landscaping.

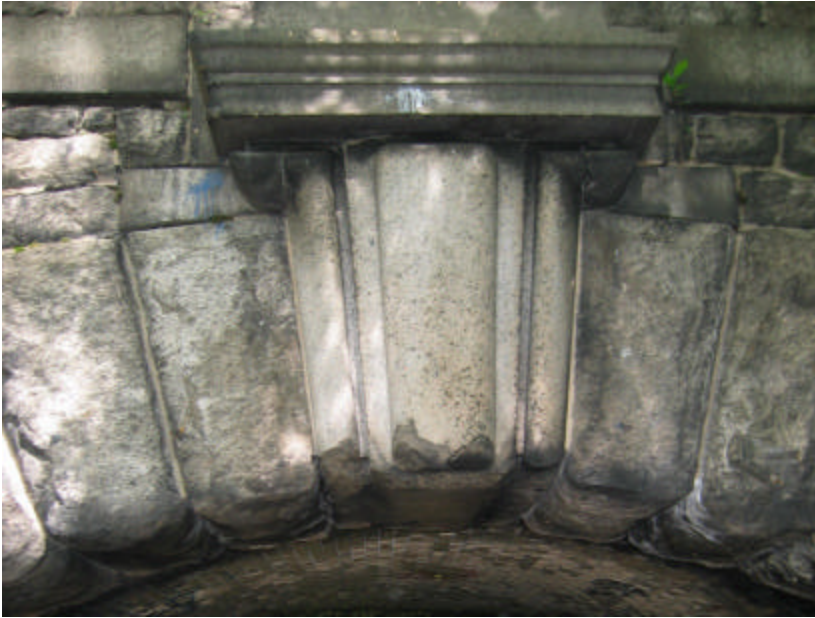
Photo 44
The keystone on the west side of the underpass; note the spalled granite on its base as well as on the other blocks.

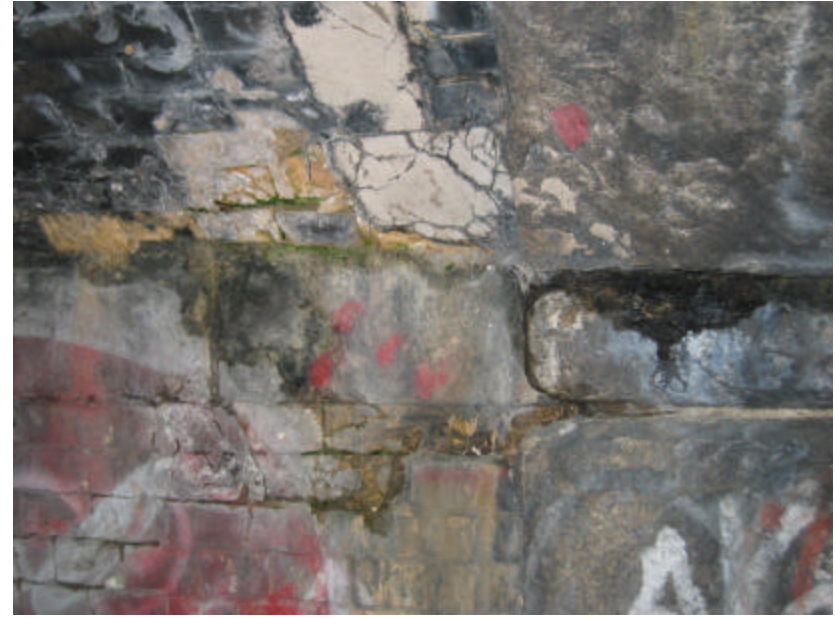
Photo 45
The arch rising from the spring course; note the cracked mortar patching and the black staining of biological growth.

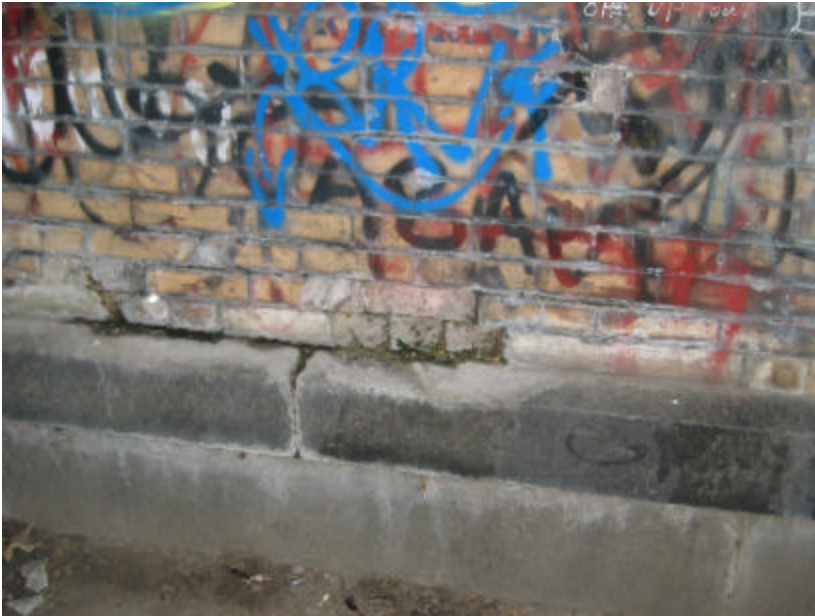
Photo 46
The granite sill along the base of the underpass; note the open joints on the brick and granite.

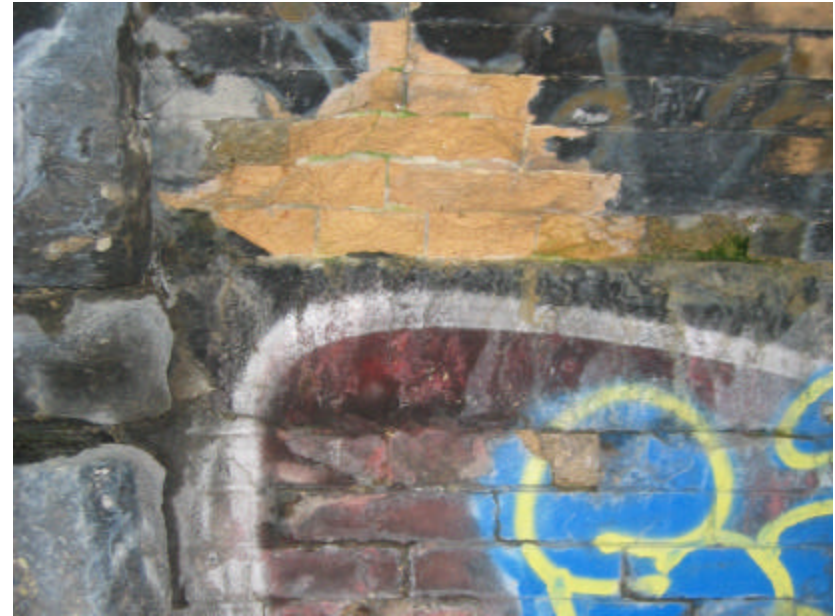
Photo 47
Spalling of brick caused by freeze-thaw cycles; note the staining and Efflorescence.

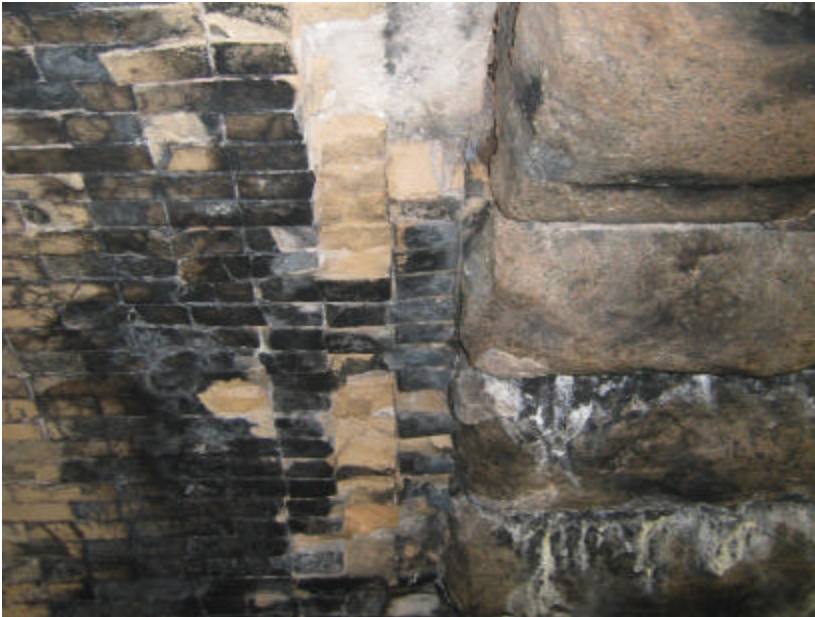
Photo 48
Missing brick from the west side of the underpass; note that this was probably caused by soluble salts leeching down from the road.

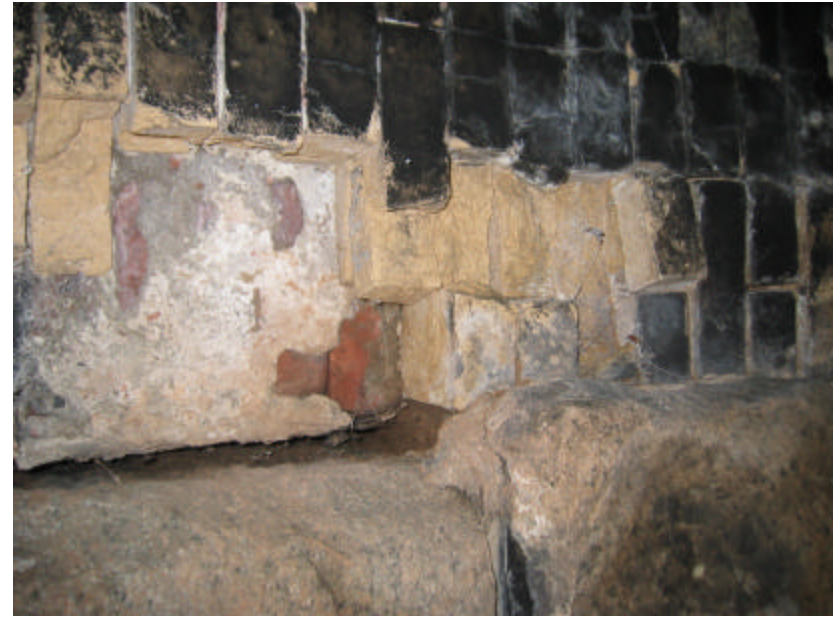
Photo 49
The bricks are so loose in some places that one can pull them out of the vault.

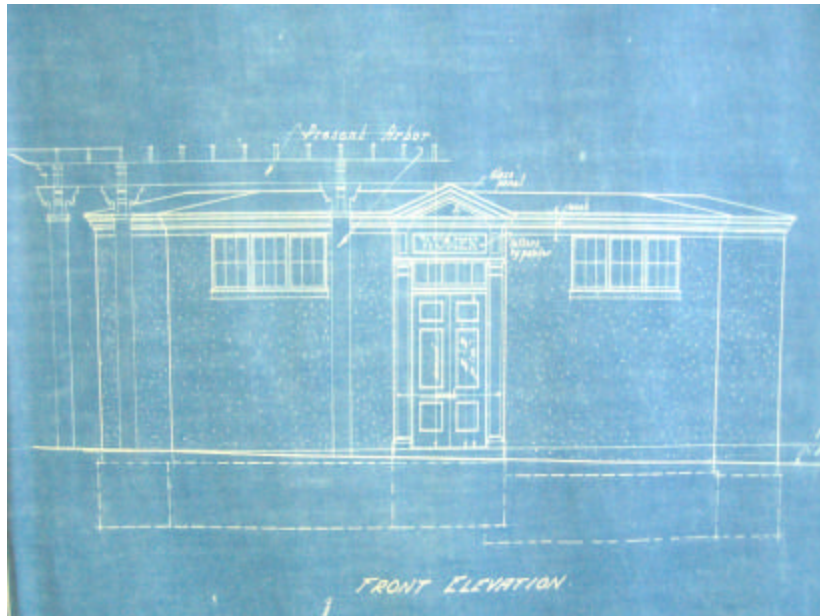
Original Drawing 9
Elevation of one of the two restrooms; note that the exterior including the arbor, windows and entrance has been dramatically altered.

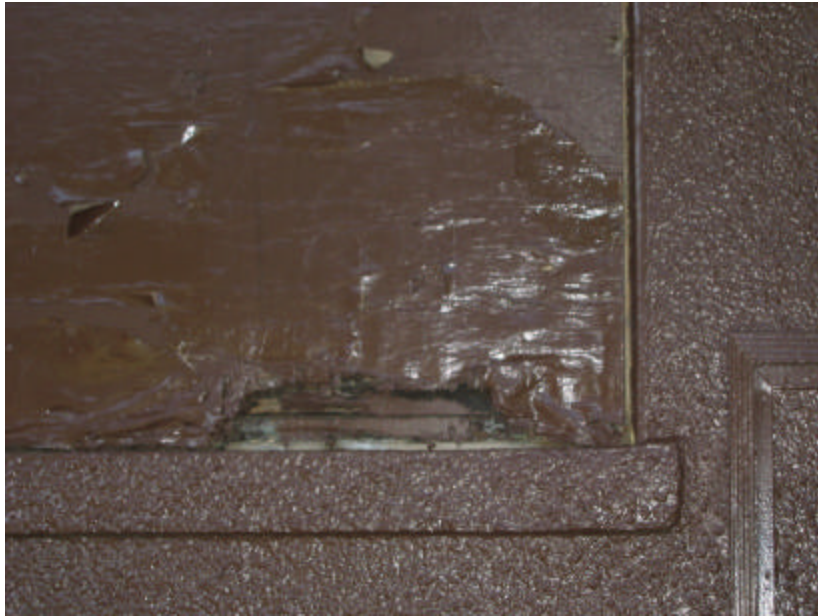
Photo 52
One of the windows that is boarded up on the north restroom; note the plywood covering has rotted because of water damage.

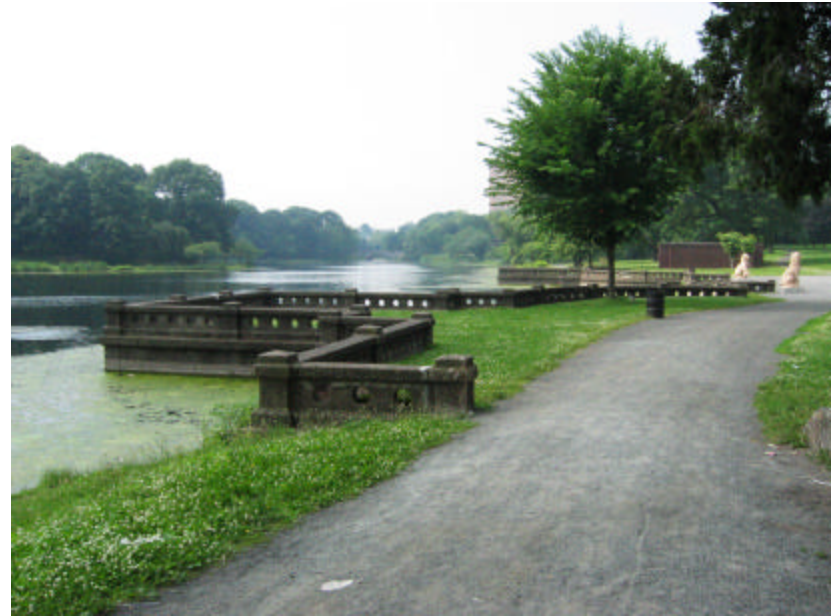
Photo 53
The boat dock is between the two lion sculptures in the distance while the balustrade spans from one restroom to the other.

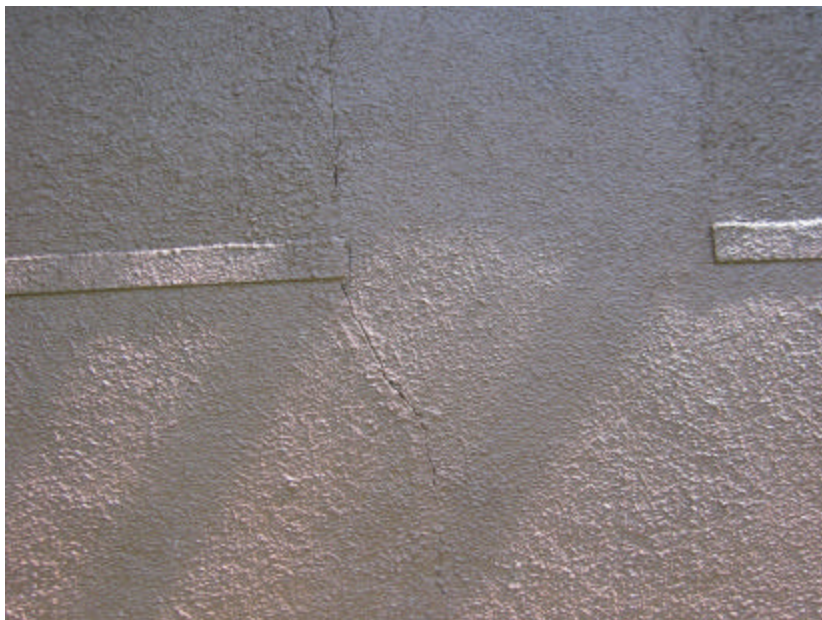
Photo 54
A full height crack in the south wall of the north restroom.

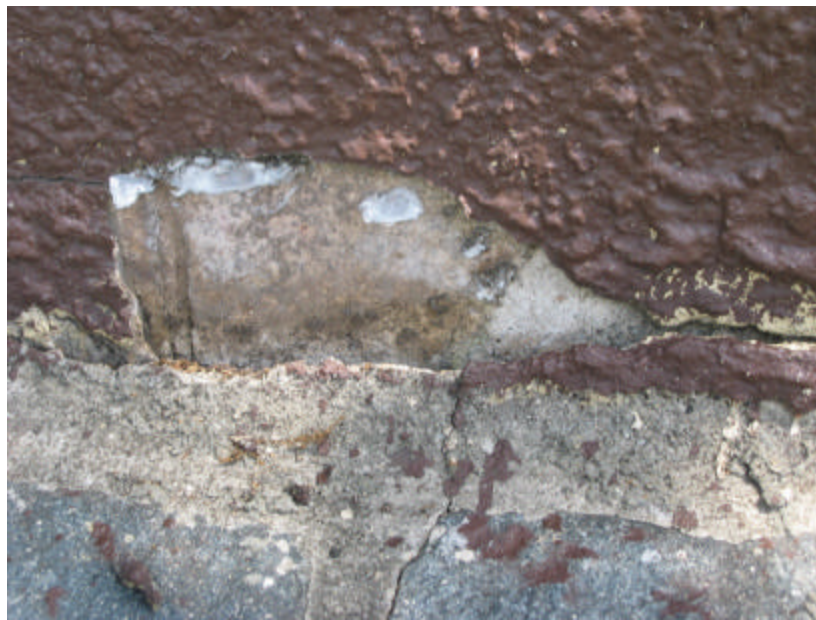
Photo 55
Stucco and mortar that has detached from the base of the north restroom.

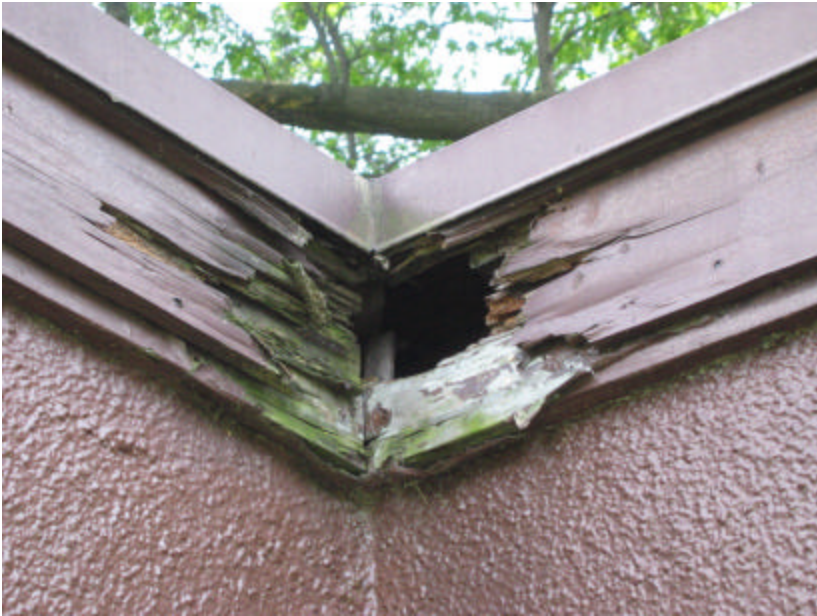
Photo 56
Damage to the wood cornice of the south restroom; note that there is a hole in the wall and that wood has rotted considerably.

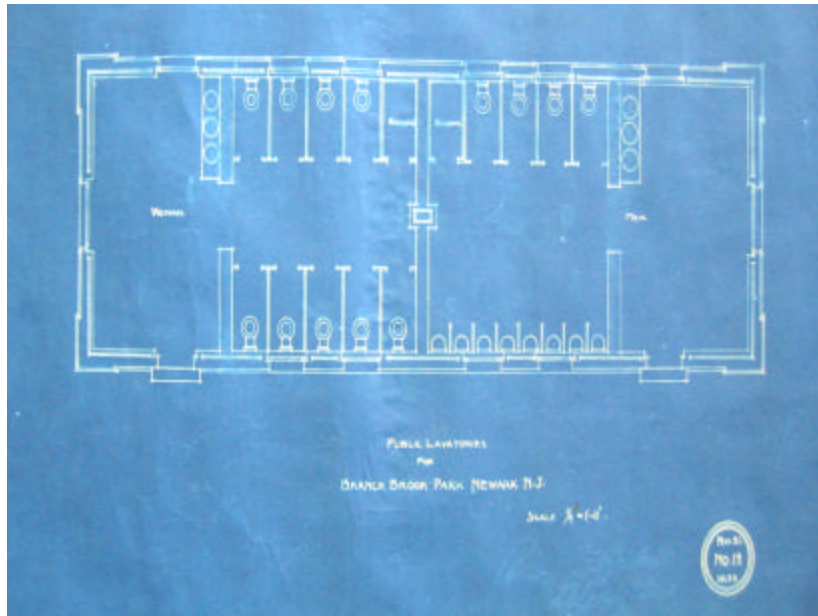
Original Drawing 11
Plan of the Playground Comfort Station.

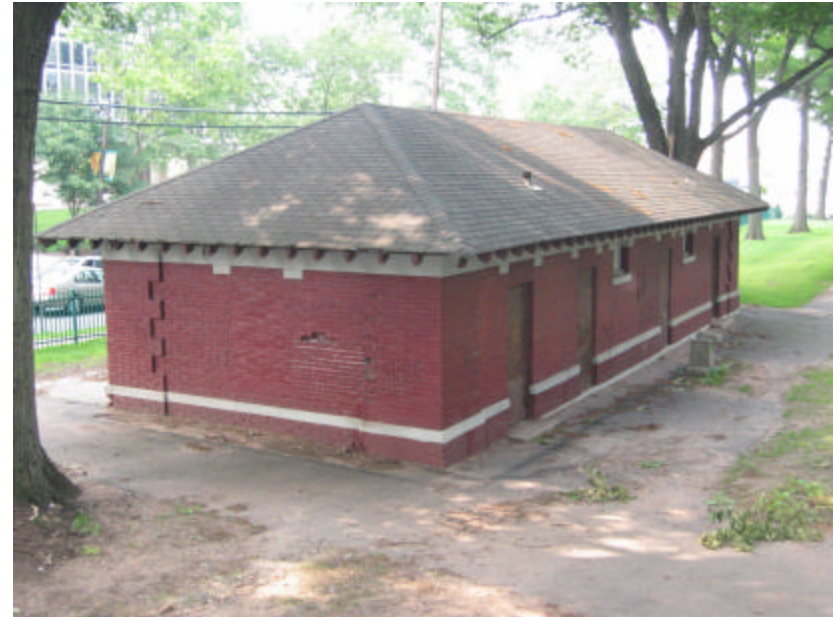
Photo 58
View looking south with Clifton Avenue on the left; note the damage to the north wall.

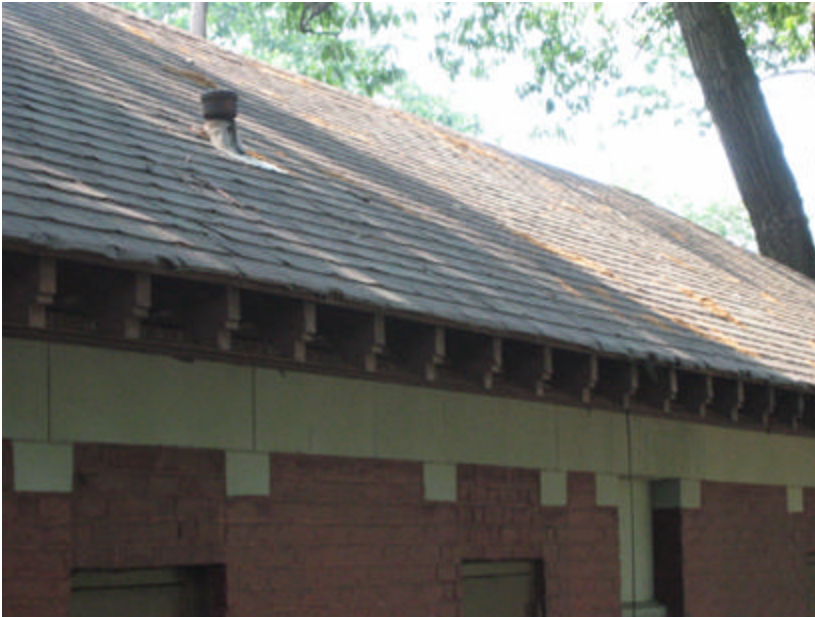
Photo 59
Vertically tooled limestone fascia; note both the brick and wall cap have been painted and the vertical joints are open.

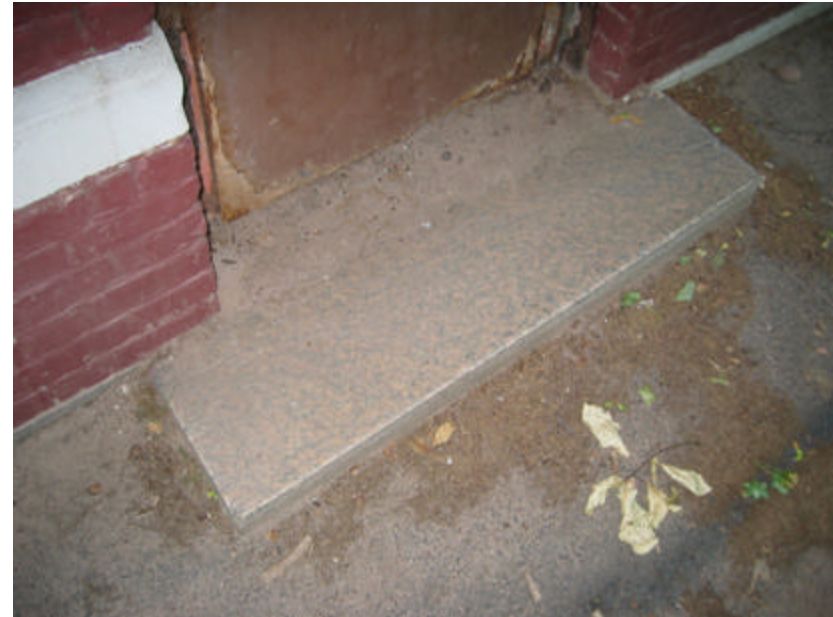
Photo 60
Granite stoop at one of the original entrances to the comfort station; note the damage to the metal clad wood door and the wear to the painted limestone trim.

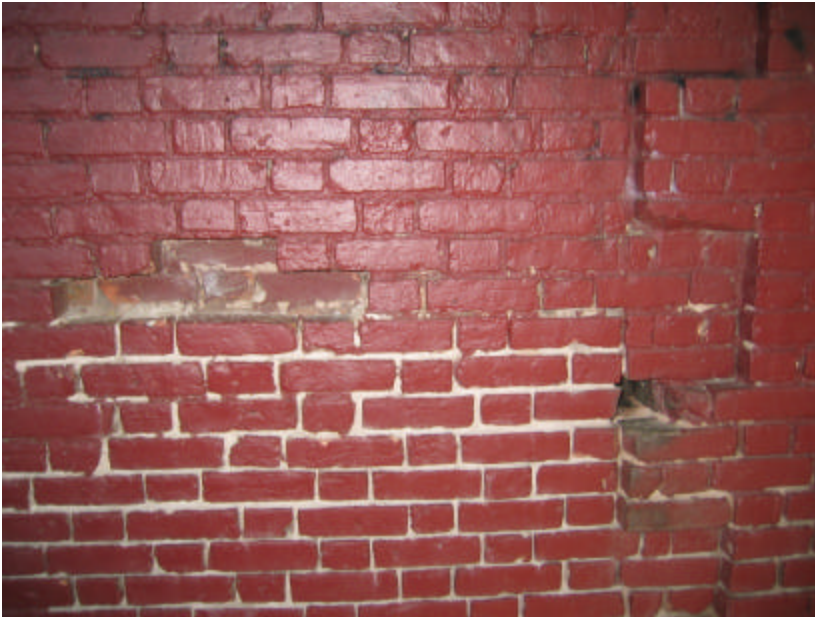
Photo 61
Severely eroded mortar joints and missing brick from the northwest corner of the comfort station; note the brick quoins on the right side of the image.

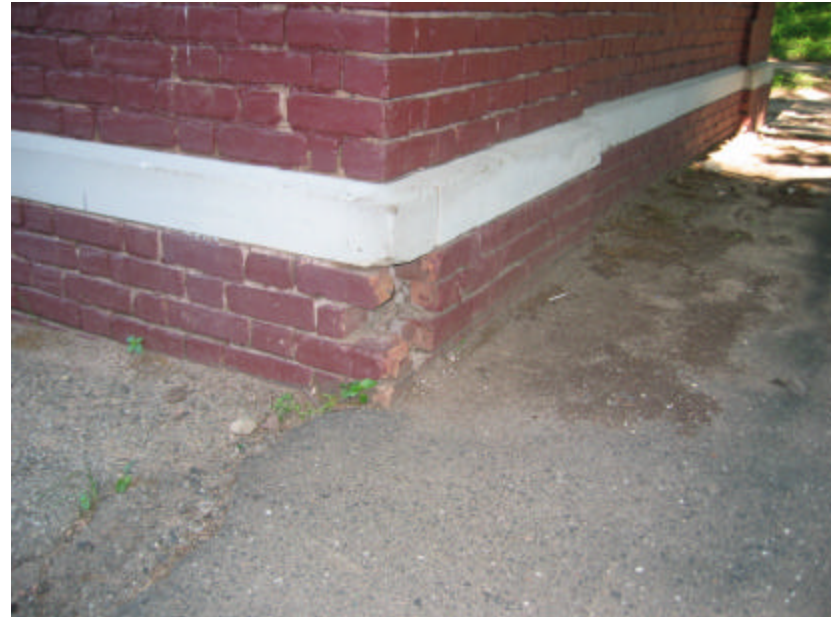
Photo 62
Missing brick from the northeast corner of the comfort station; note that all the brickwork needs to be repointed.

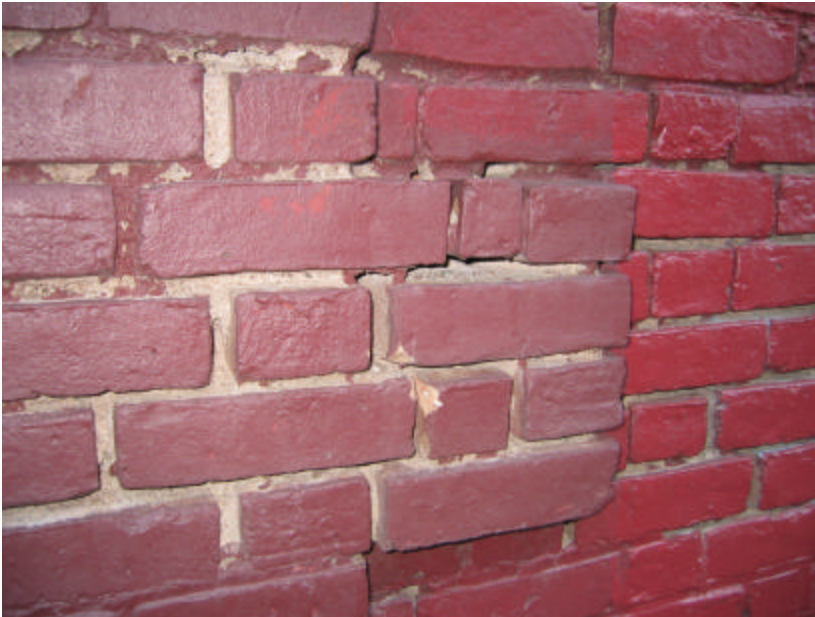
Photo 63
Detail of bricks on the east wall of the building; note that the mortar has almost fully eroded between the bricks.

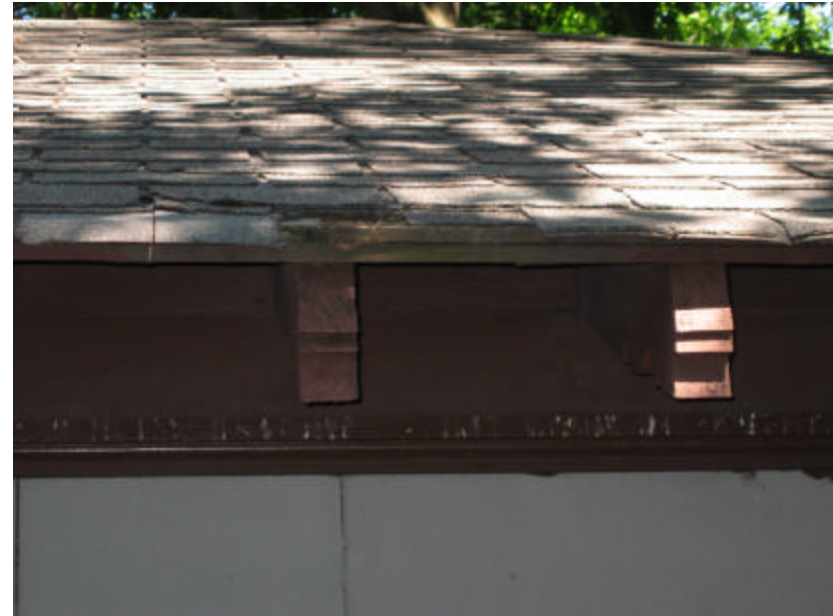
Photo 66
Rotted and broken roof sheathing; note that the asphalt roof tile has
failed here and on most edges of the building.

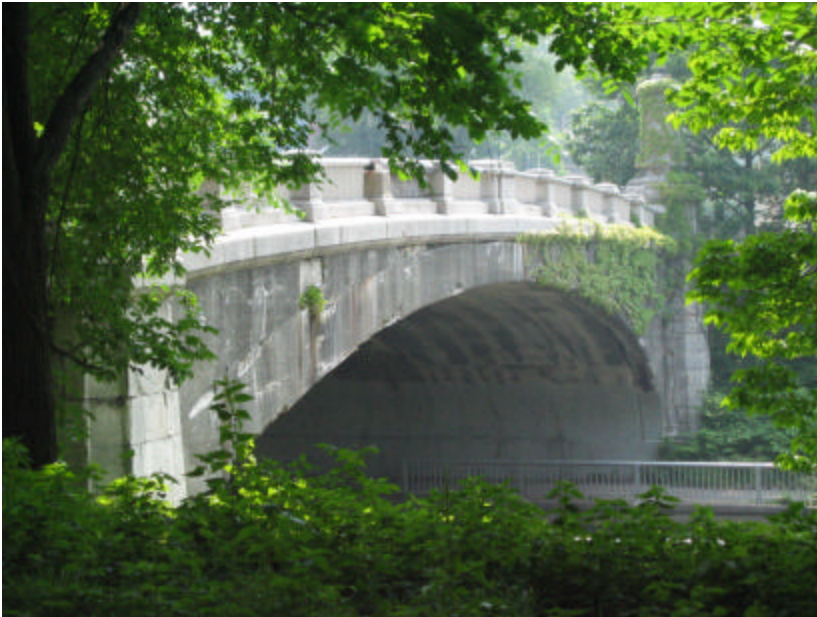
Photo 67
The Park Avenue Bridge from the southwest embankment; note the soiled and fractured face of the arch.

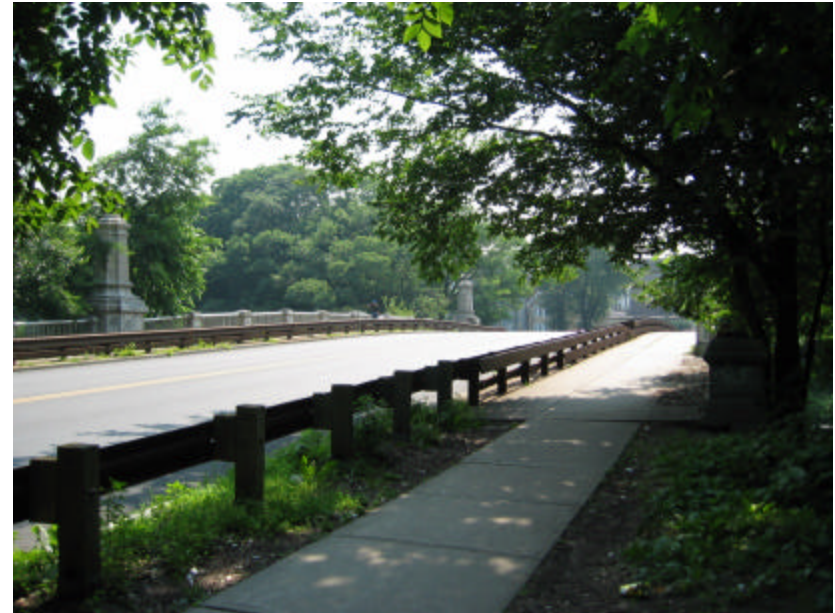
Photo 68
Park Avenue going over the bridge; note the rusted steel vehicular guardrail on both side of the road.
