Cultural Landscape Report, Treatment, and Management Plan for Branch Brook Park

Newark, New Jersey

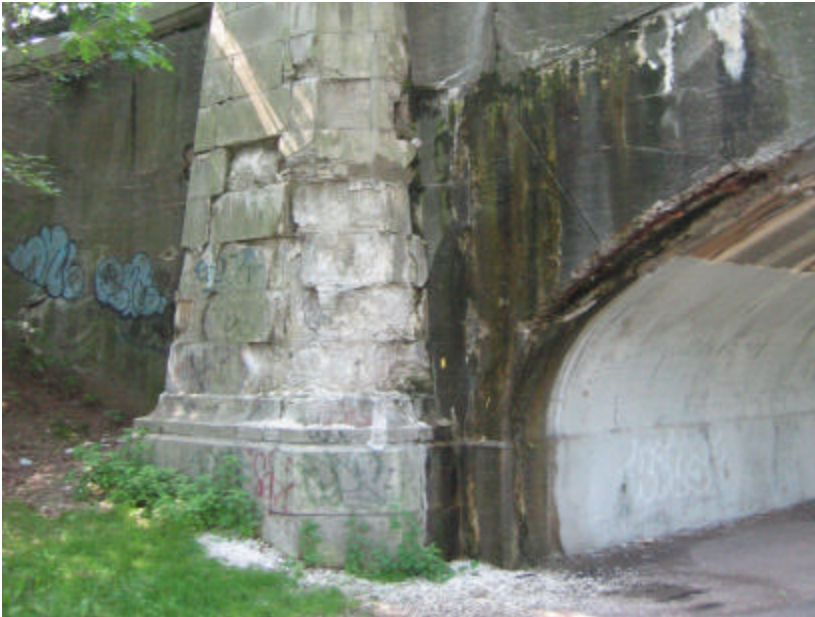
Photo 69
Cracked and spalling concrete on the northeast buttress; note the graffiti, efflorescence and green and black biological growth.

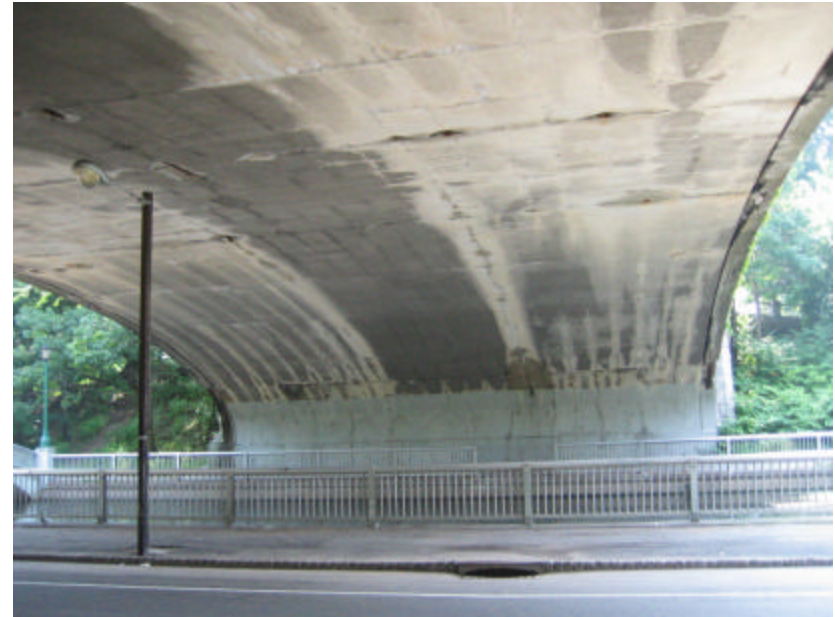
Photo 70
Soiling and spalling on the underside of the bridge; note both the vertical and horizontal cracking.

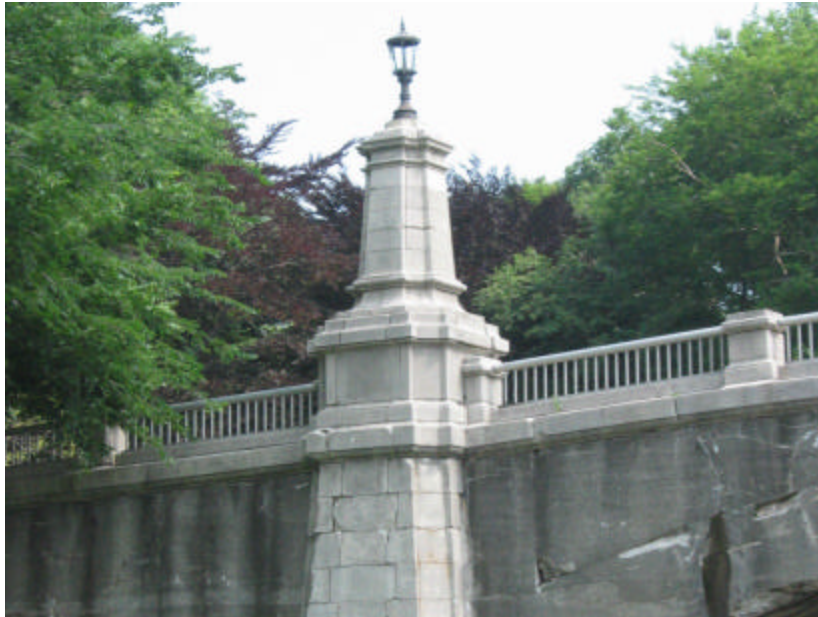
Photo 71
The southeast butters and lamppost; note that this butters is capped by its original luminary.

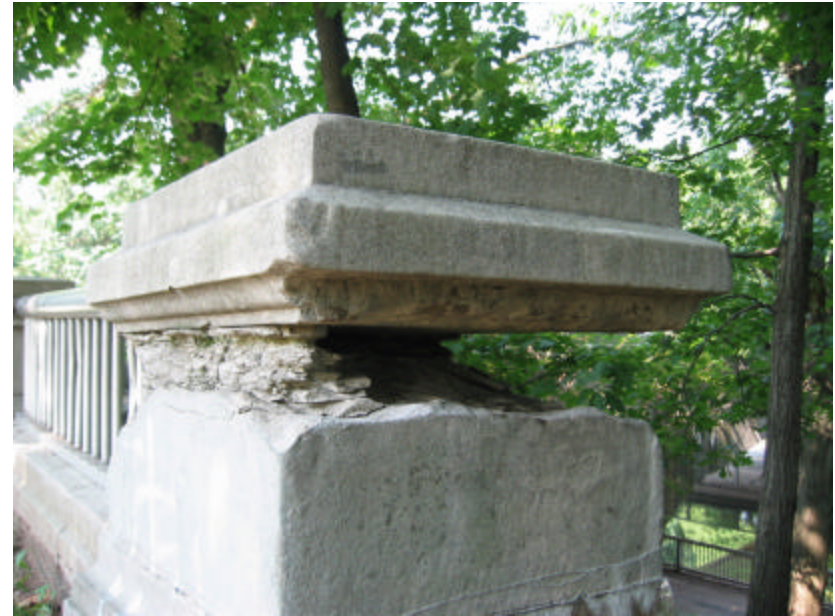
Photo 74
Severe weathering and spalling of concrete on the northeast pedestal; Note that the location is directly below the cap at the bed joint.

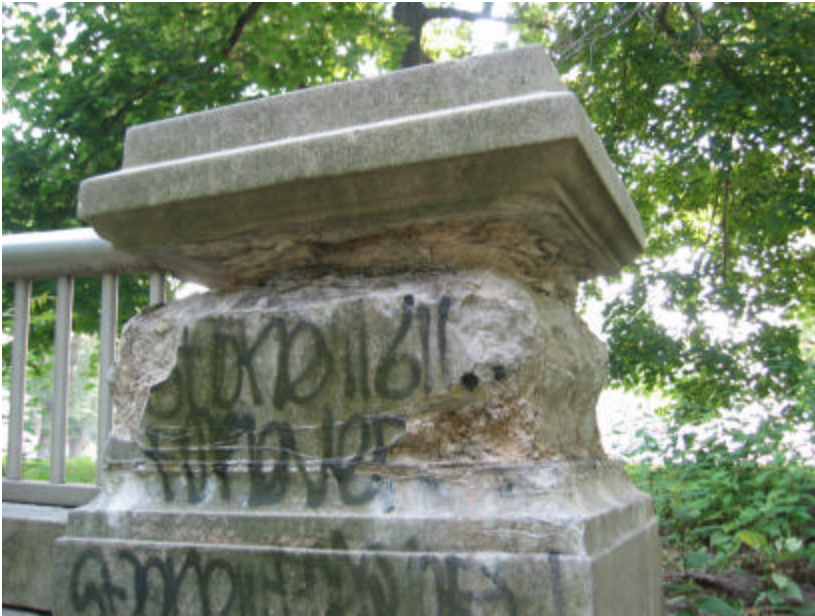
Photo 75
Severe weathering and spalling of concrete on the southeast pedestal; note that the damage has occurred in the same place.

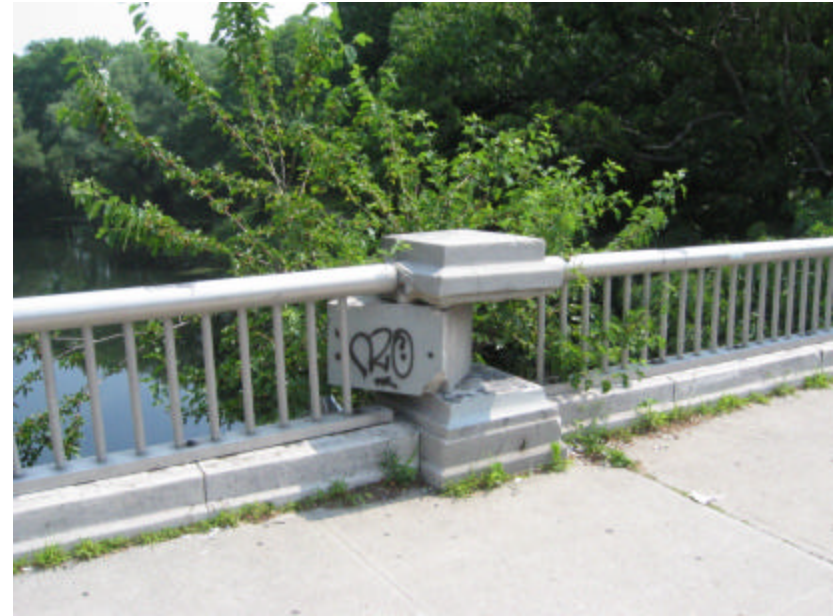
Photo 76
Displaced concrete post in the balustrade; note that this is an extremely dangerous situation since this block could fall, causing a fatal injury.

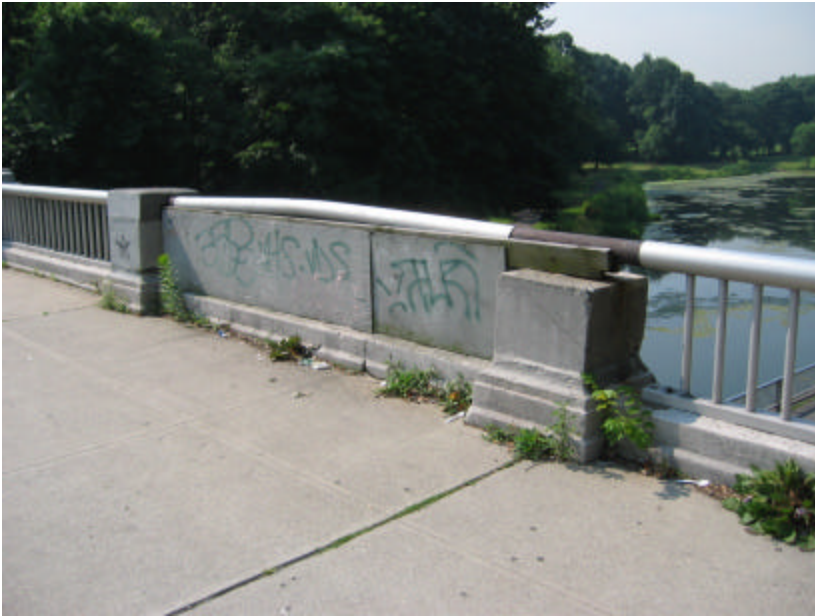
Photo 77
These two posts are severely damaged and missing their caps; note the missing railing as well.

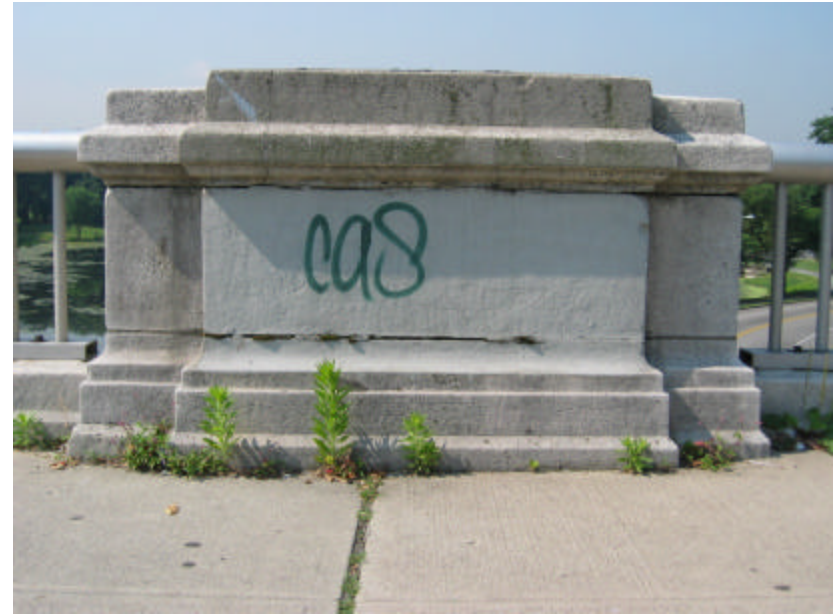
Photo 78
The center railing post on the south side of the bridge; note that it has been patched but still remains in poor condition.

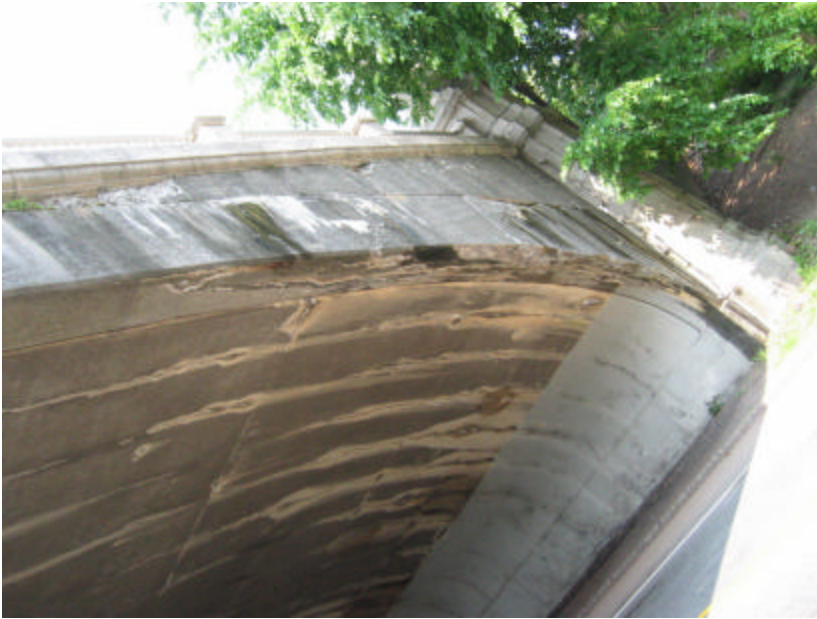
Photo 79
The north side of the bridge; note the heavily soiled surface, cracking and spalling.

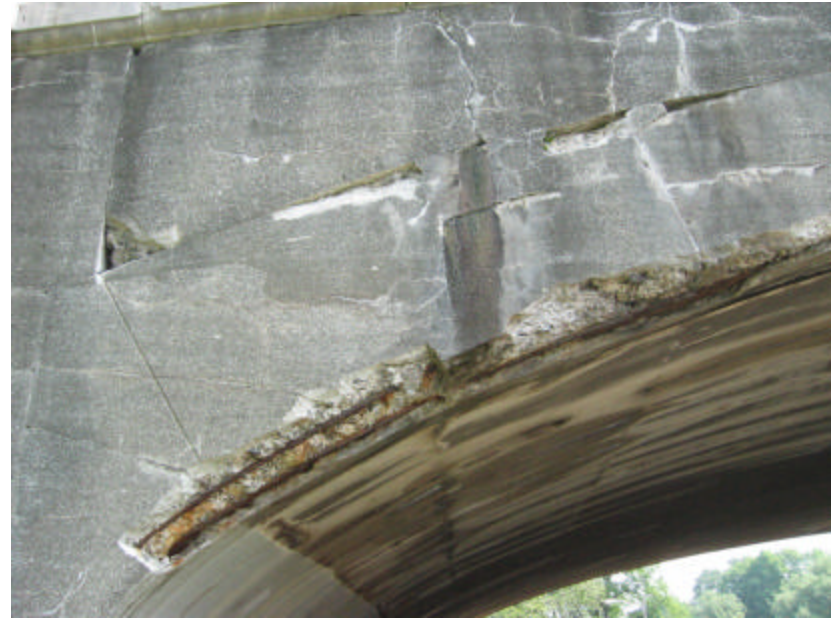
Photo 80
The southwest face of the bridge; note the rusted, exposed steel reinforcing in the concrete.

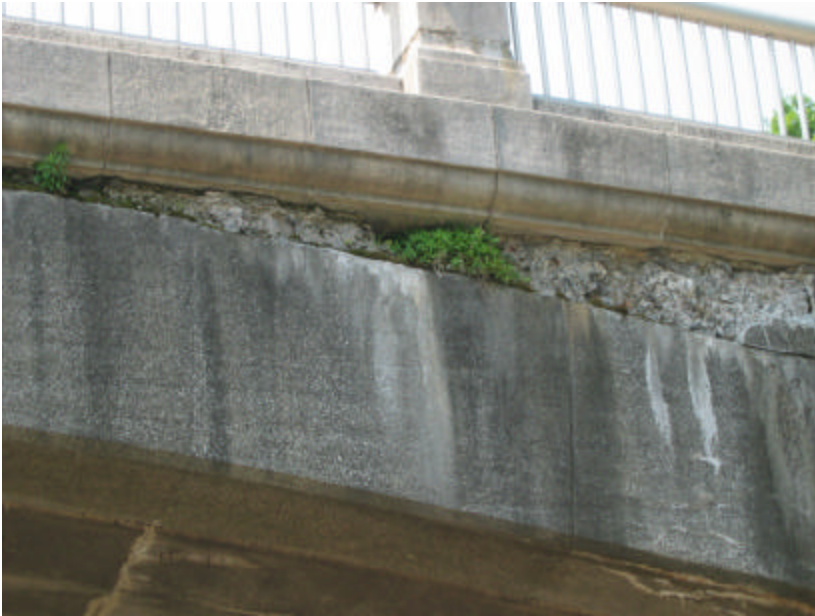
Photo 81
The face of the south arch of the bridge directly below the railing; note that this area of spalling is approximately 10' - 0" long.

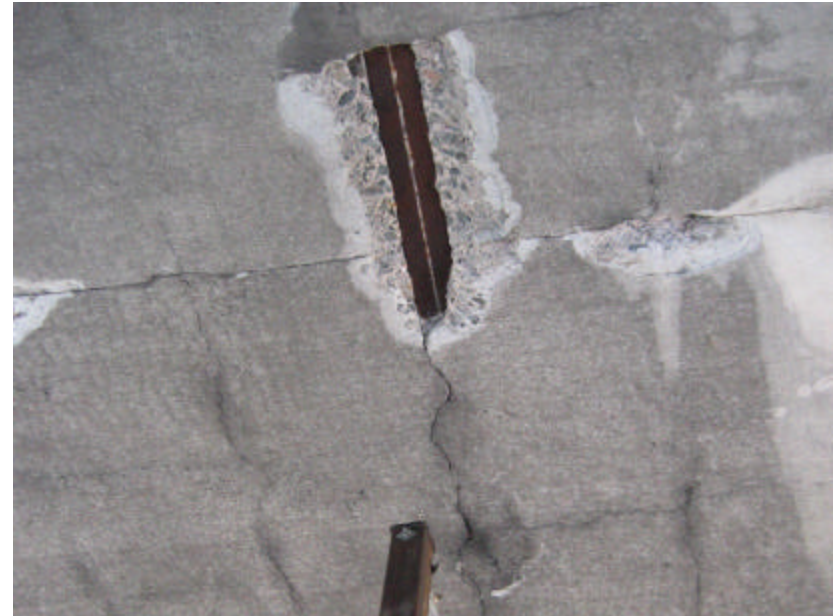
Photo 82
Exposed and rusting section of the Melan arch; note that this may cause severe structural damage to the bridge.

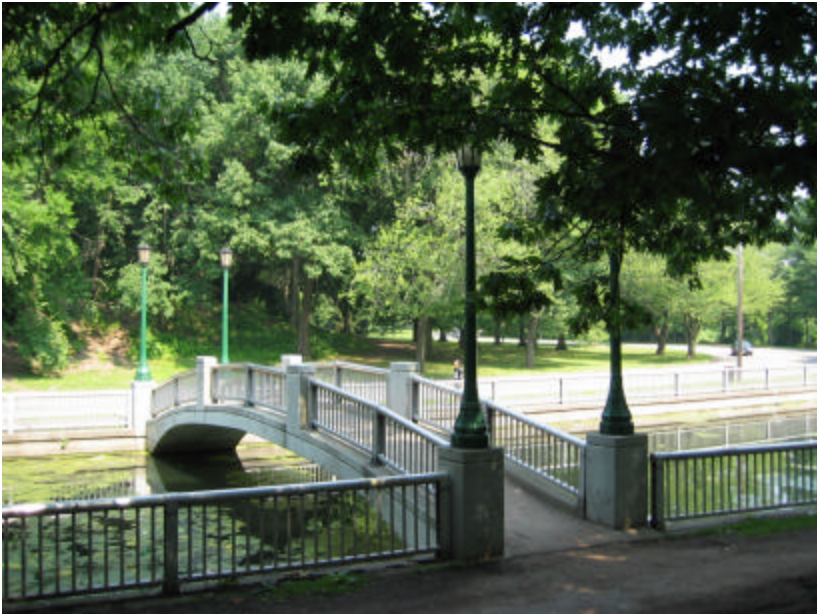
Photo 83
The concrete arched footbridge crossing over the channel between the two sections of Branch Brook Lake; note the aluminum railing and lamp posts.

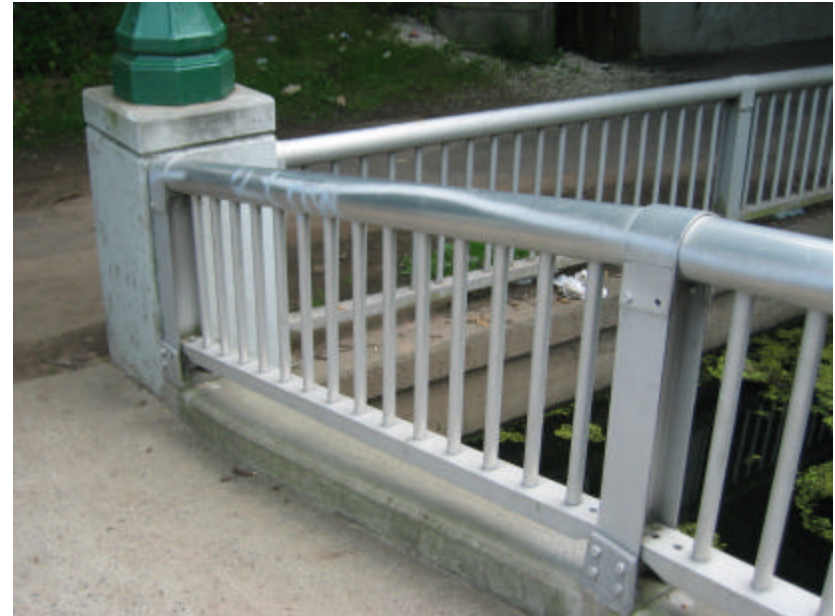
Photo 86 A concrete post at the north end of the footbridge; note the A section of the aluminum railing that is covered with graffiti.
A concrete post at the north end of the footbridge; note that the aluminum railing is in good condition overall, but sections are covered with graffiti.

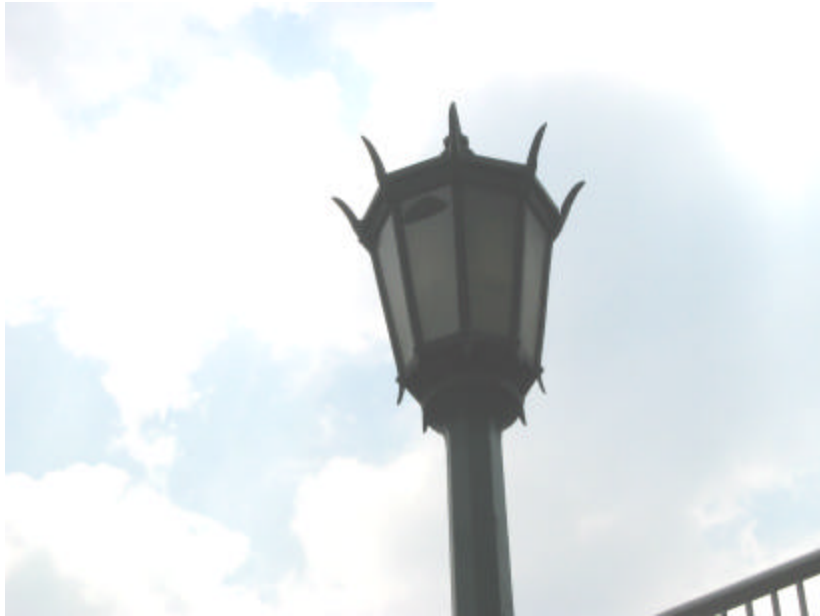
Photo 87
A section of broken glass in the lamppost on the southwest side of the footbridge.

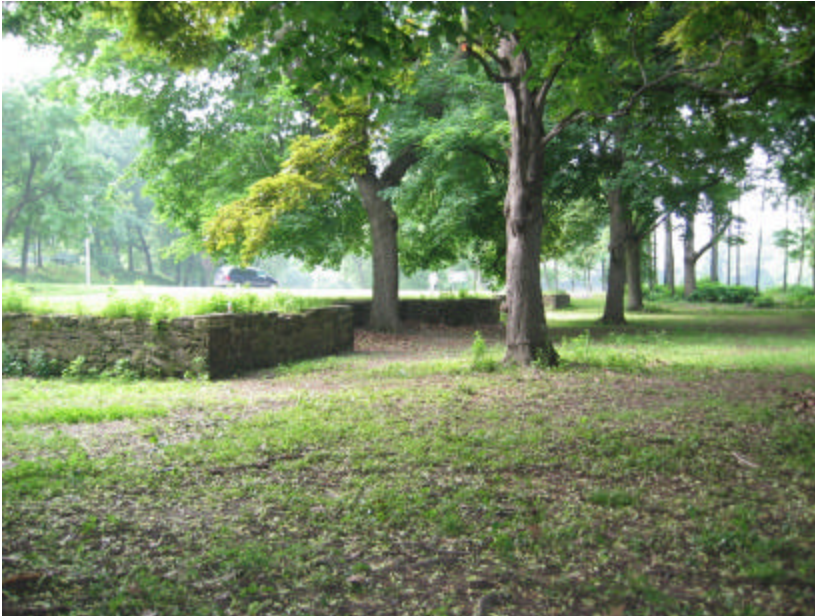
Photo 88
View of the remains of the "Dutch Garden" retaining wall; note all the spots of bare earth around the site.

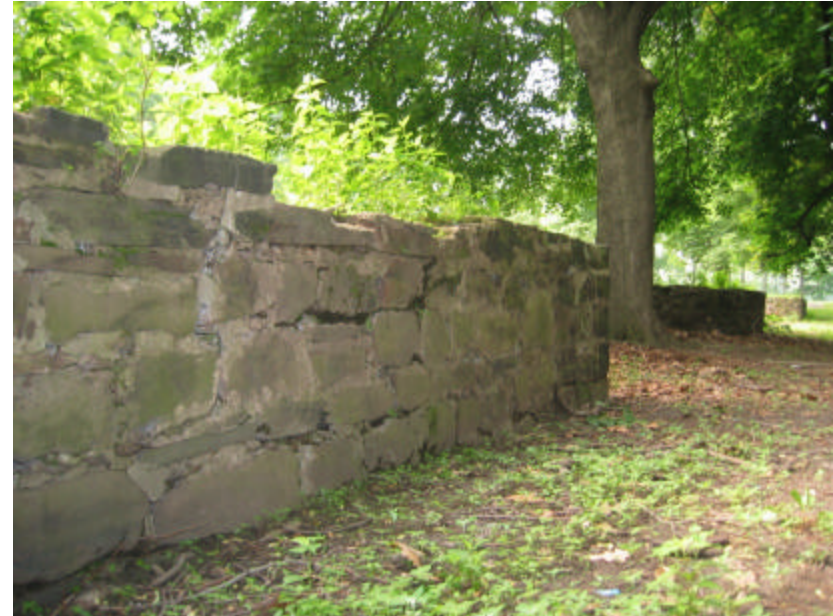
Photo 89
View of wall, stone and mortar details; note the missing coping stones at the top of the wall.

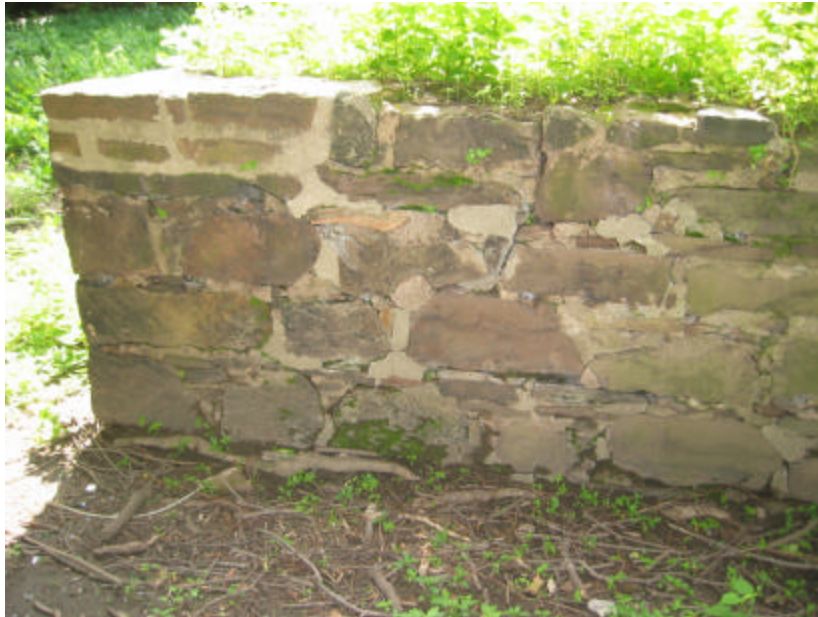
Photo 90
Erosion around the base of the wall; note that the stones at the top of the wall are typically smaller than at the bottom.

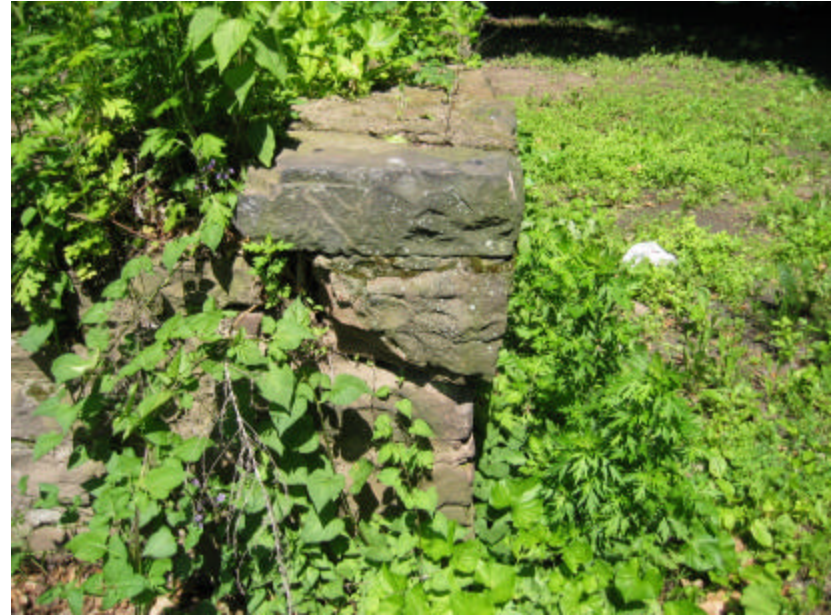
Photo 93
Plant growth coming from a cracked corner of the wall.

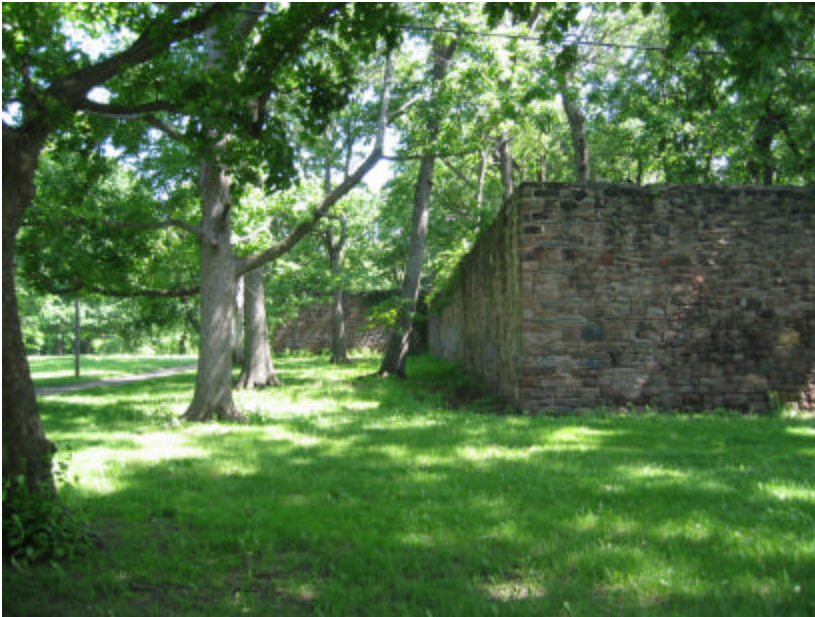
Photo 94
View looking north, the high mound terrace wall ruin.

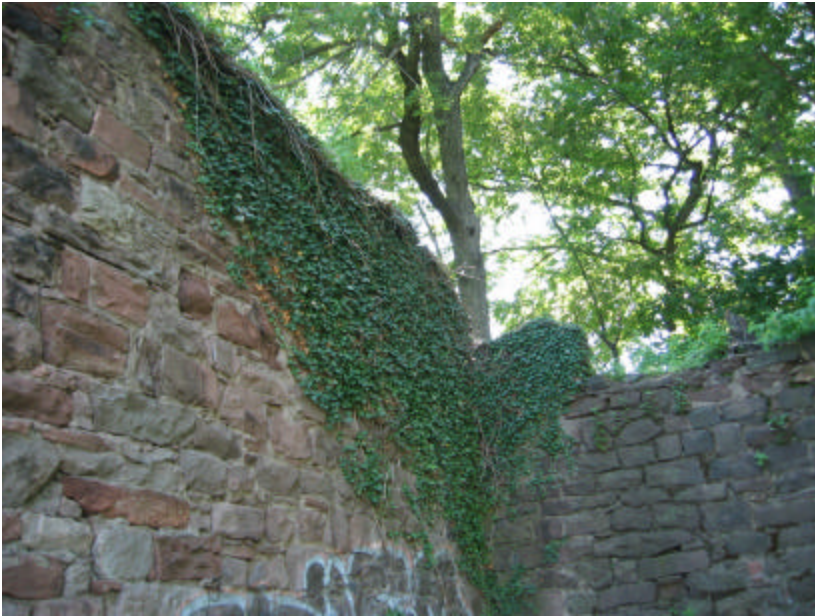
Photo 98
Stones missing from the parapet; note that smaller coping stones are also missing and that ivy is overgrowing a large section of the wall.

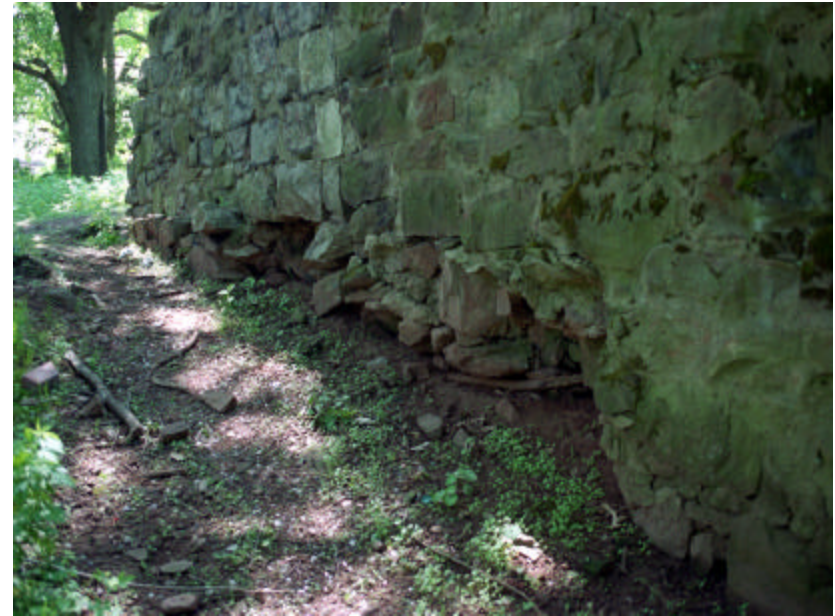
Photo 99
Large amounts of stone missing from the base at the north side of the wall; note that the wall has cracked here because the wall structure is unstable.

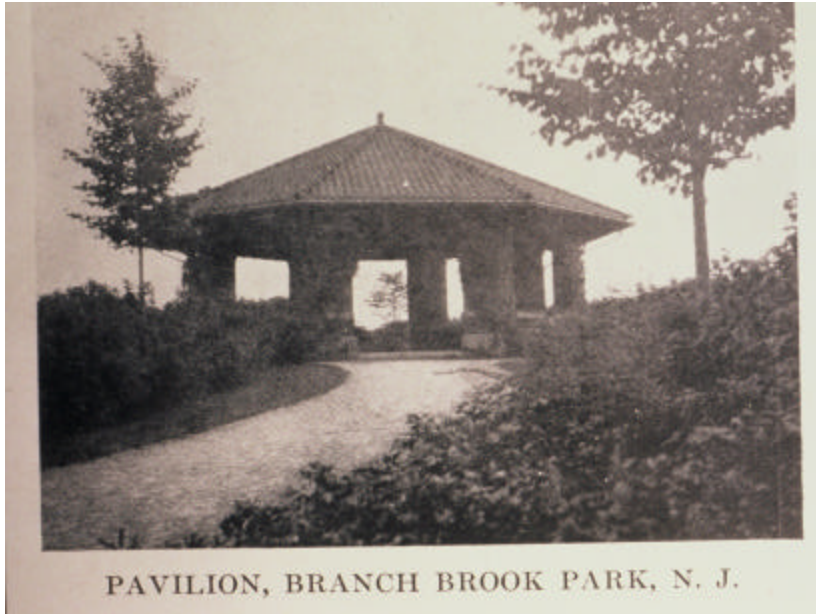
Historic Image 1
Early photograph of the Octagon Shelter.

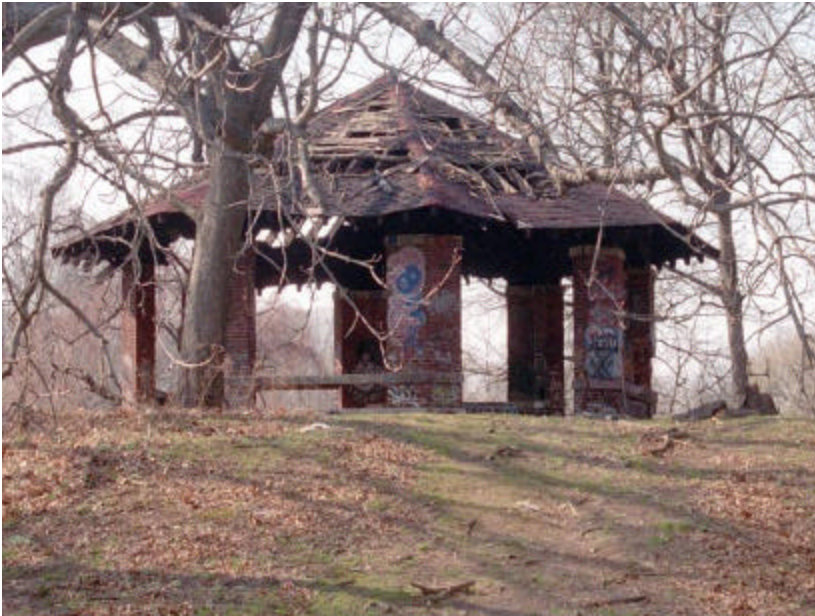
Photo 102
View of The Octagon Shelter from the south; note extensive roof damage and graffiti.

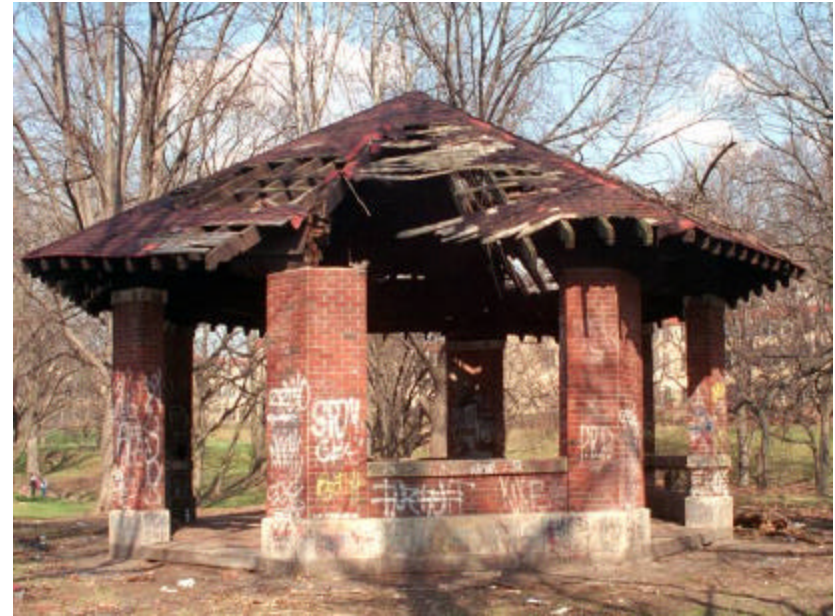
Photo 103
View of The Octagon Shelter from the southwest (side 6 closest); note absence of beams which support wood roof structure.

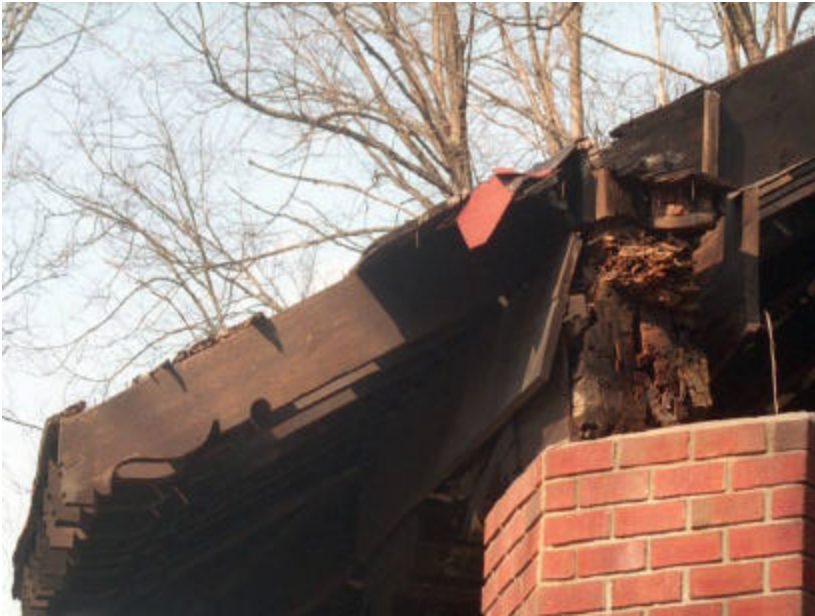
Photo 104
Detail of The Octagon Shelter, column 6.5, of missing roof support beam showing rot of remaining beam as well rot at adjacent roof rafters; note that the roof rafters extend over the beam as decorative eave supports

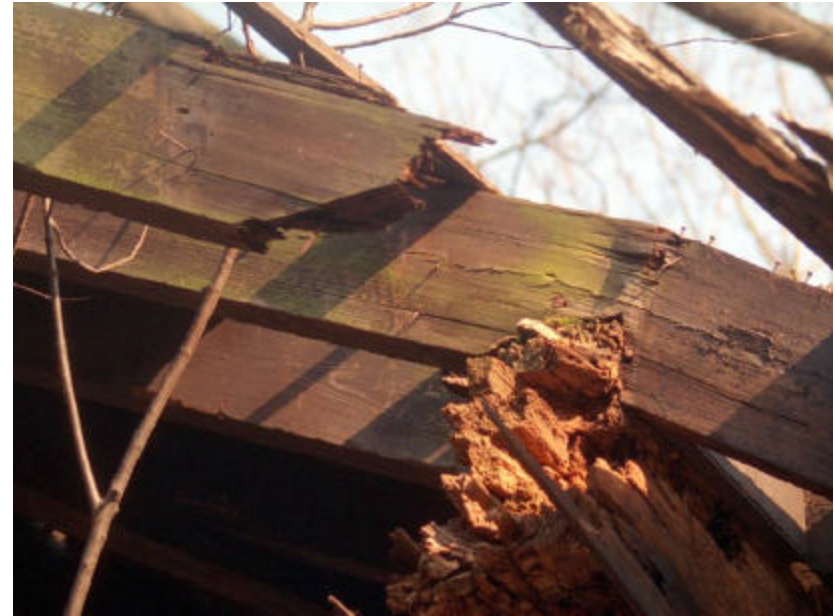
Photo 105
Detail of The Octagon Shelter, column 5.5, showing missing roof support beam, over side 6, and rot and failure of roof rafters.

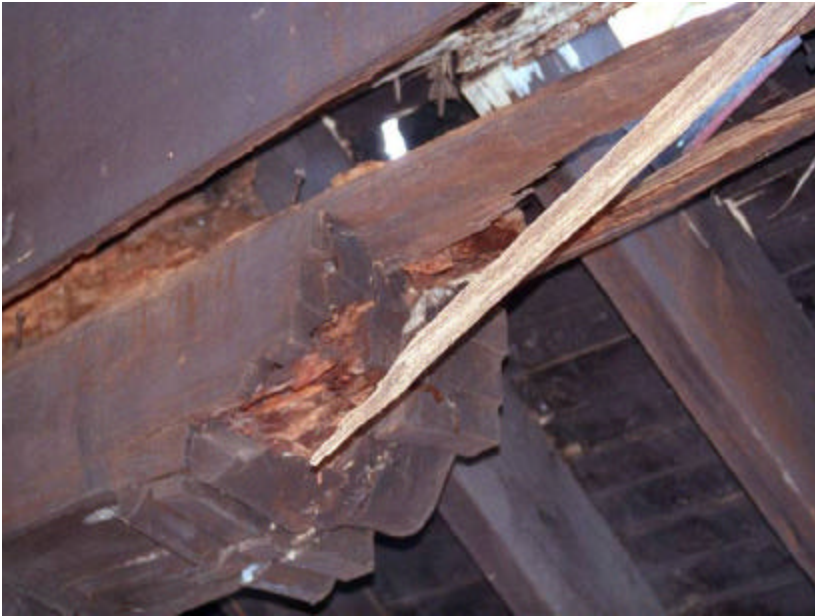
Photo 106
Detail of The Octagon Shelter showing extensive rot of roof support beam; note typical decorative, beam support bracket.

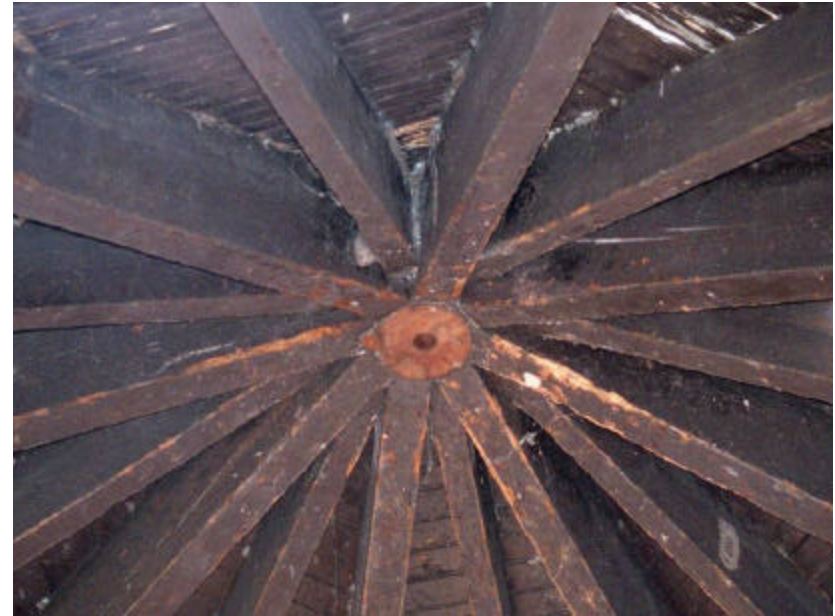
Photo 107
Detail of The Octagon Shelter roof structure; each of 8 major rafters rests on a column and smaller rafters (7 on each side) frame into the major rafters.

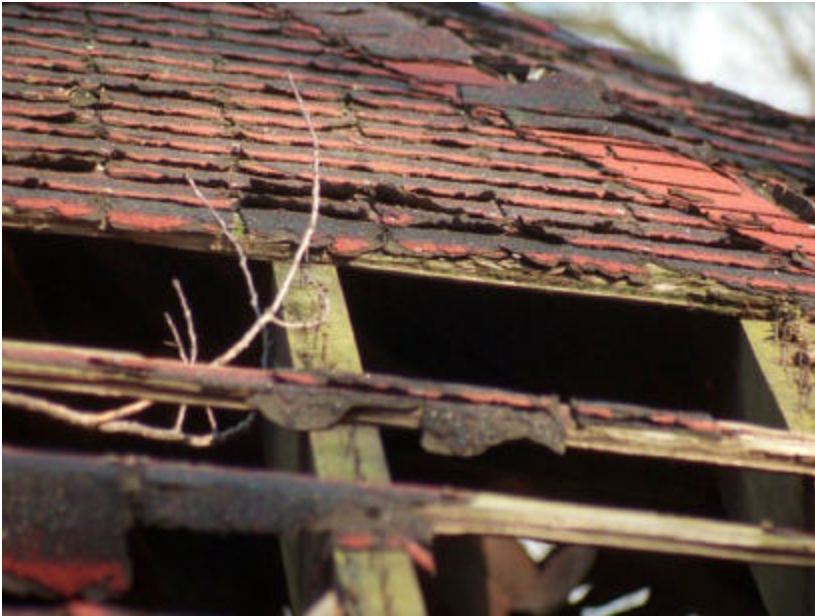
Photo 108
Detail of The Octagon Shelter showing missing wood roof sheathing and failed asphalt shingle roofing.

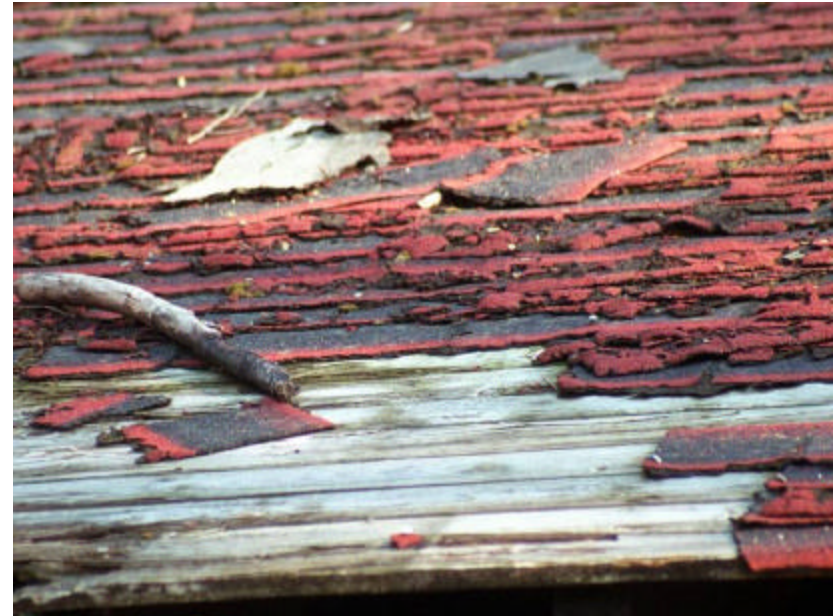
Photo 109
Detail of The Octagon Shelter showing failed asphalt shingle roofing and exposed wood roof sheathing.

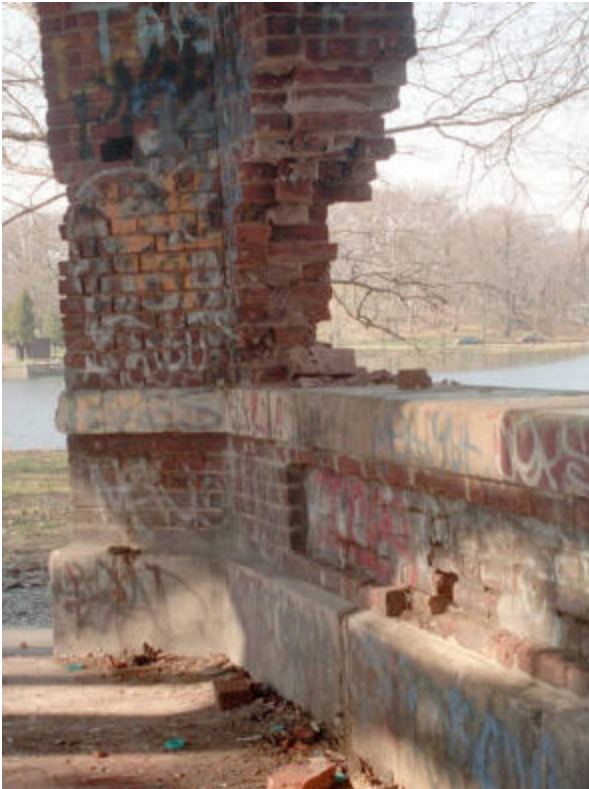
Photo 110
Detail of The Octagon Shelter showing missing brick at column 1.5;
note that all masonry surfaces are covered with graffiti.

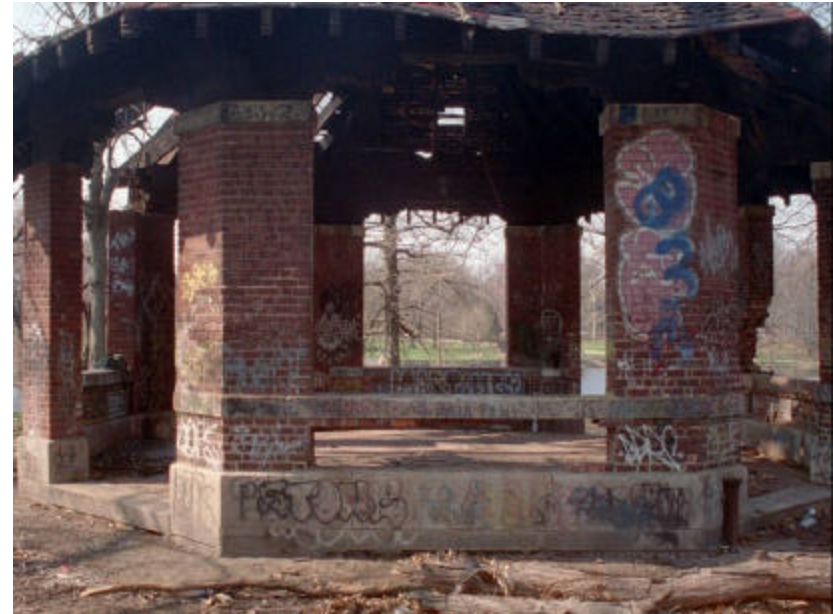
Photo 111
Detail of The Octagon Shelter showing missing brick at side 4 low
wall; note that the limestone sill now spans between brick columns.

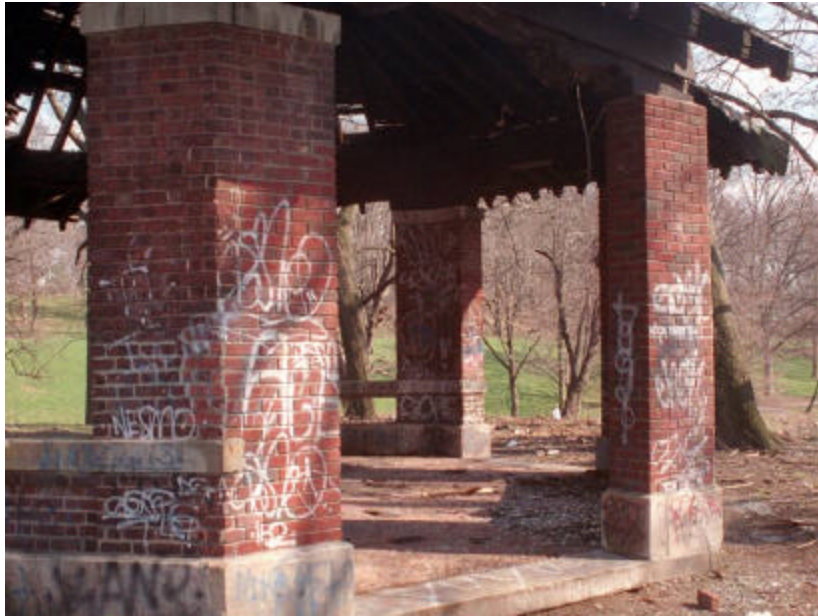
Photo 112
Detail of The Octagon Shelter from the west showing reconstructed brick columns, (No. 7.5 to the left); note that the limestone sills were altered, and do not divide the column as originally constructed.

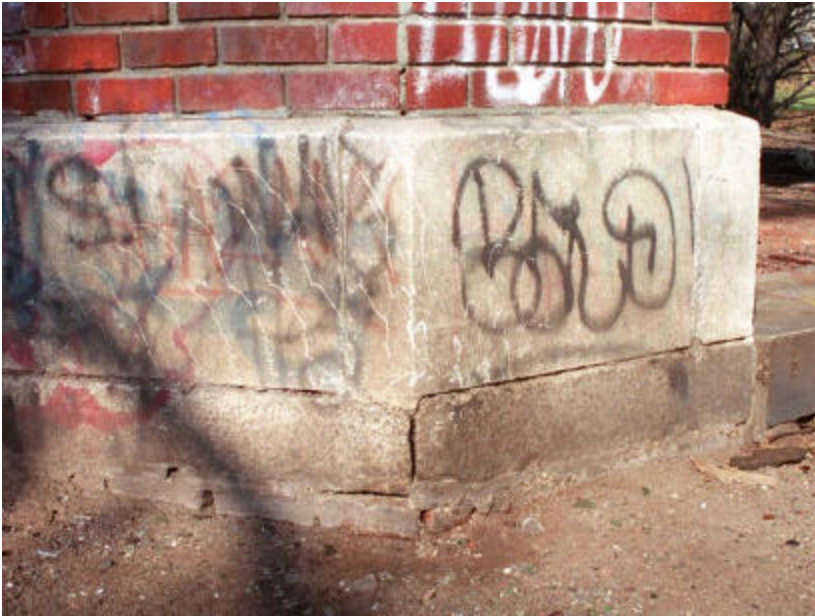
Photo 114
Detail of The Octagon Shelter, column No. 5.5 limestone base with brick foundation exposed by soil erosion, under granite plinth; note that the open corner joint indicates some differential settlement.

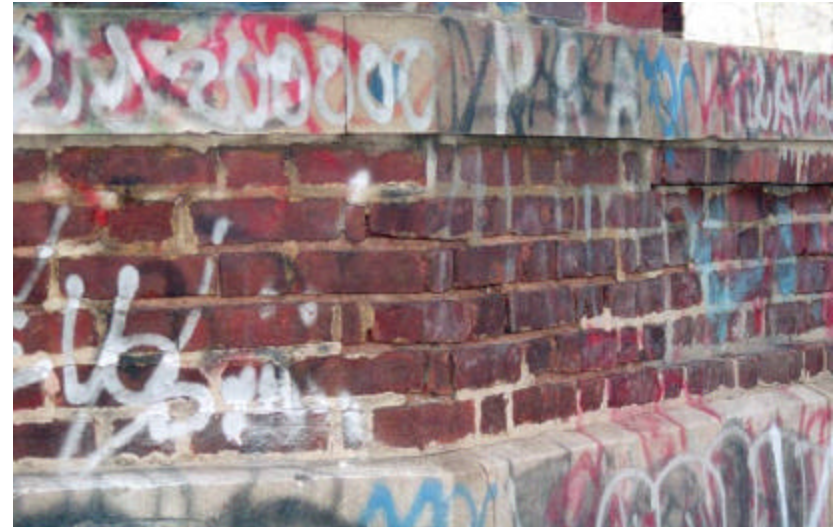
Photo115
Detail of The Octagon Shelter showing typical brick low wall with eroded mortar joints, selective repointing with non-matching mortar and graffiti; note that the original mortar joints are tinted similar to the brick color.

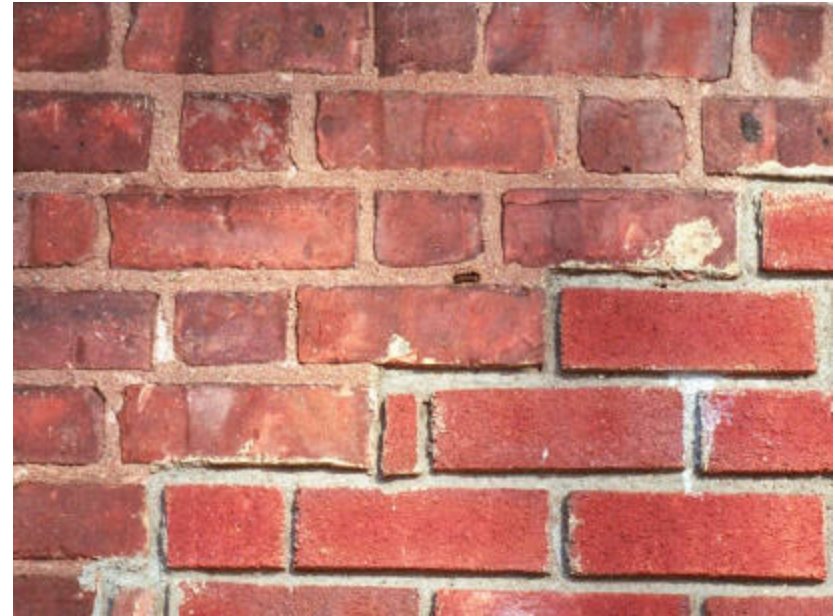
Detail of The Octagon Shelter showing cracked limestone sill at column No. 2.5; note that, although virtually all stone mortar joints have failed, there is only limited cracking and spalling.

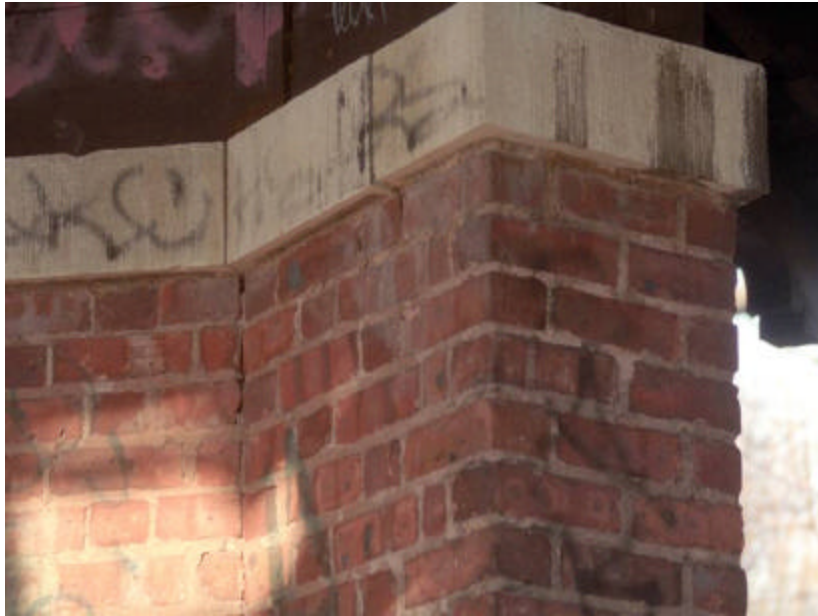
Photo 118
Detail of The Octagon Shelter showing limestone column caps above brick column No. 2.5; note that the higher brick mortar joints are in better condition than those closer to the sill.

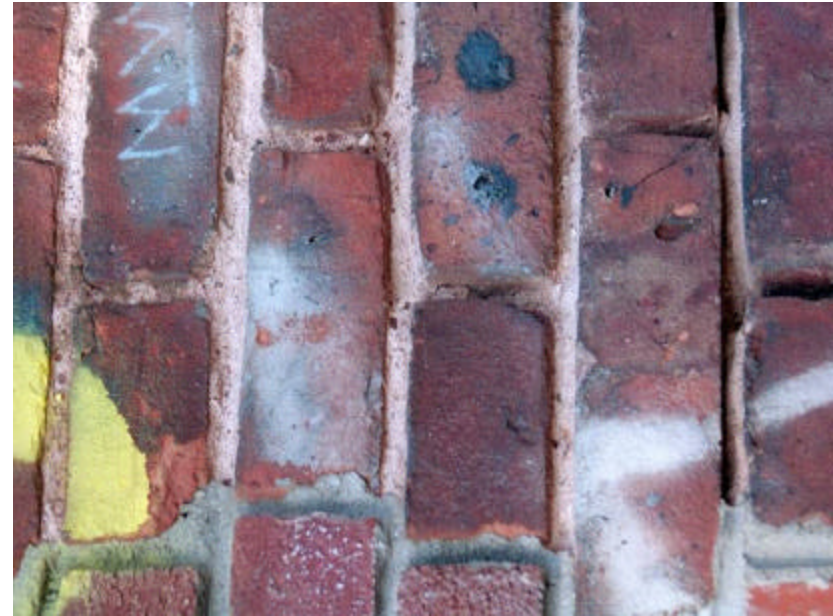
Photo 119
Detail of The Octagon Shelter showing typical, original, eroded, tinted brick mortar joints; note non-matching gray mortar.

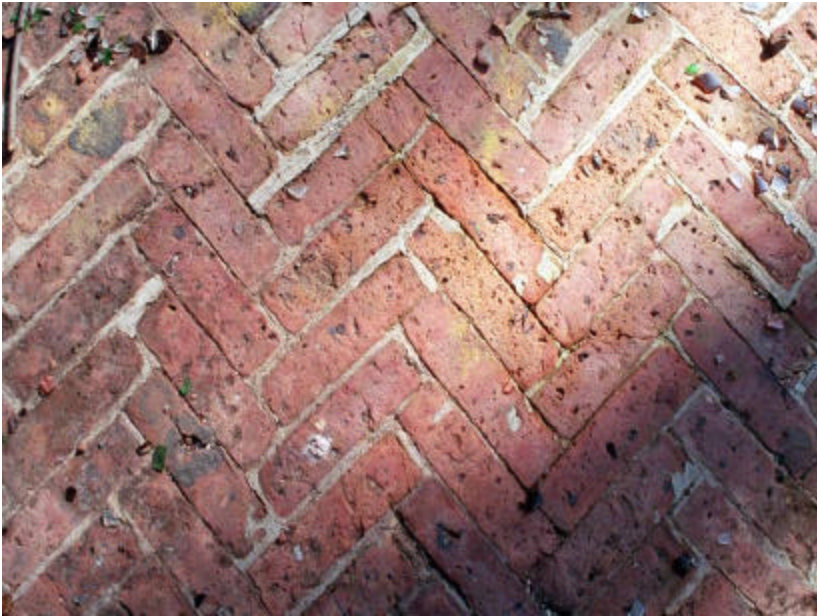
Photo 120
Detail of The Octagon Shelter showing typical “herringbone”-
patterned, brick paving; note that the bricks are typically pitted with
almost all missing, eroded or repointed mortar joints.

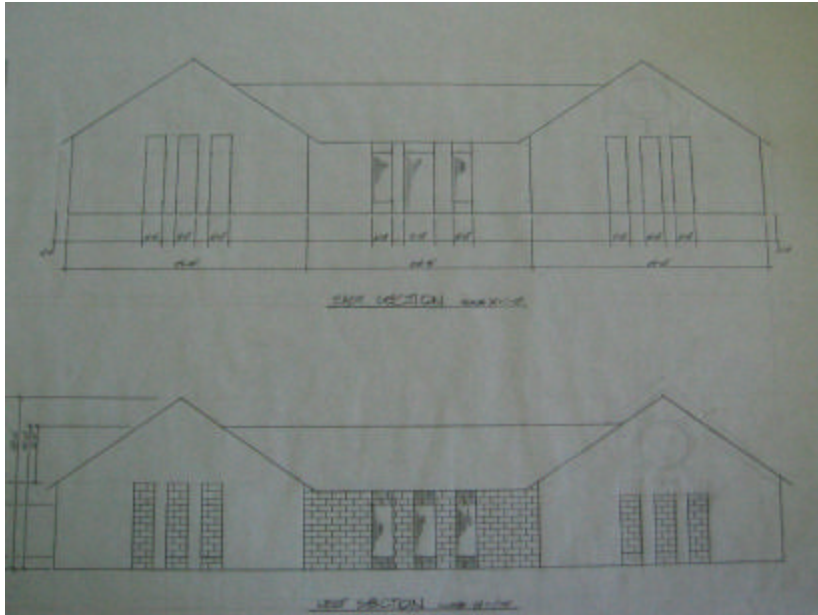
Original Drawing 16
This drawing shows elevations of both the east and west facades and was prepared by the Essex County Parks Commission.

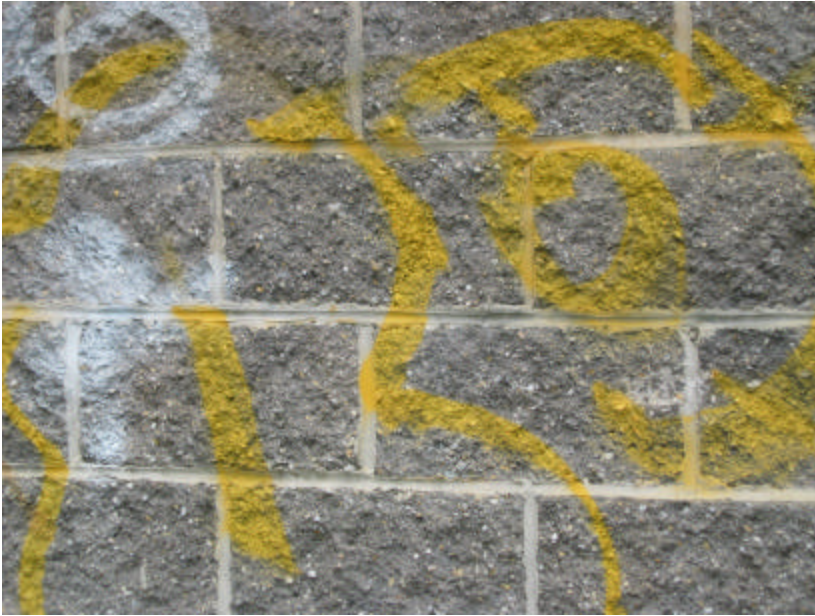
Photo 126
Gray split face concrete masonry units laid in a running bond pattern; note that they are in good condition except for the graffiti.
