Cultural Landscape Report, Treatment, and Management Plan for Branch Brook Park

Newark, New Jersey

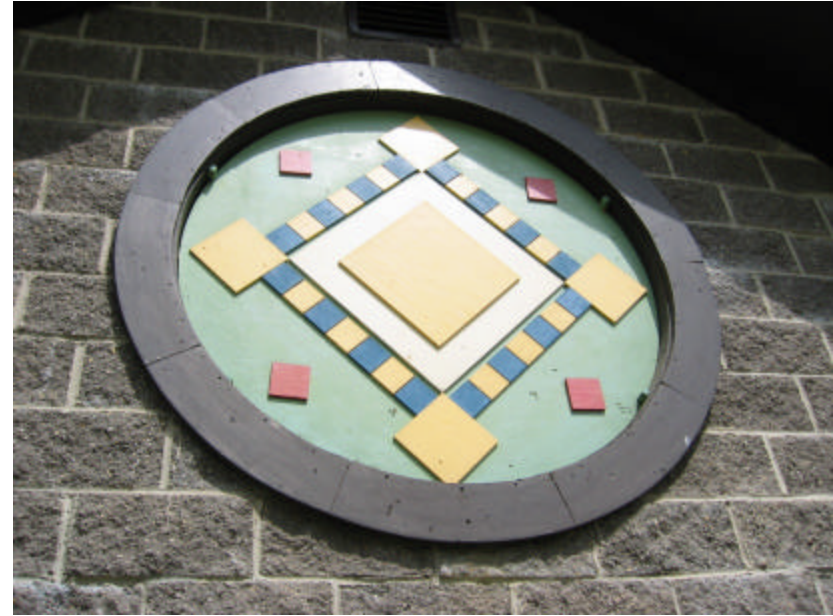
Photo 127
One of the four wood medallions; note that this one is located on the southeast side of the building.

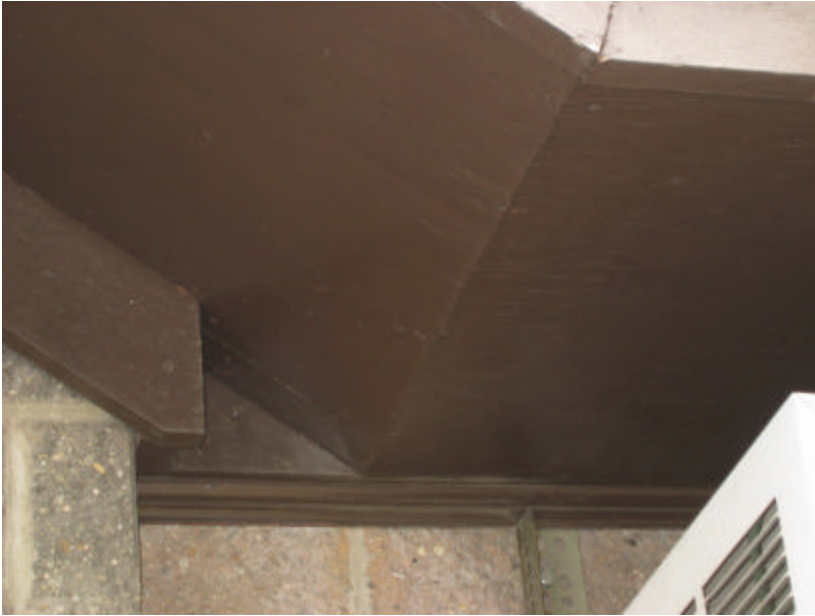
Photo 128
The painted plywood soffit of the cornice; note that it is in good condition with only slight wear.

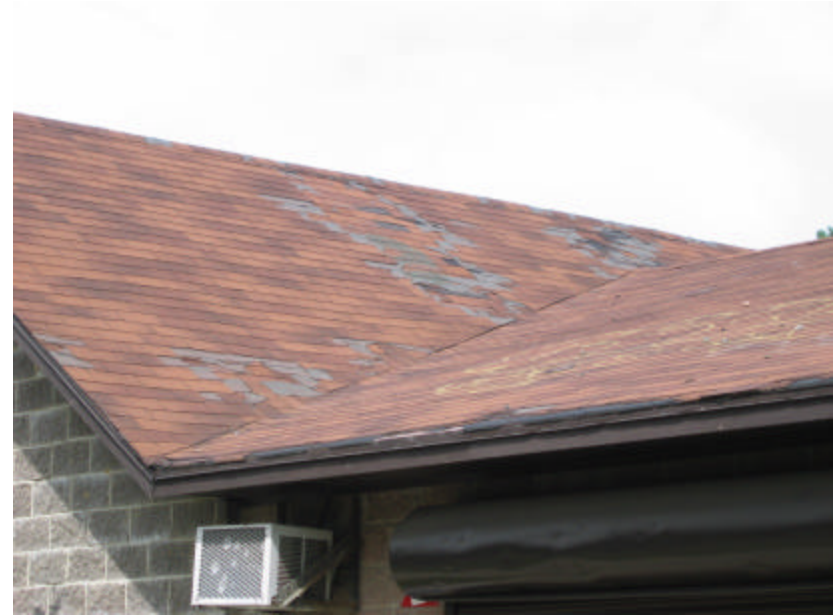
Photo 129
Missing and damaged shingles on the south end of the roof.

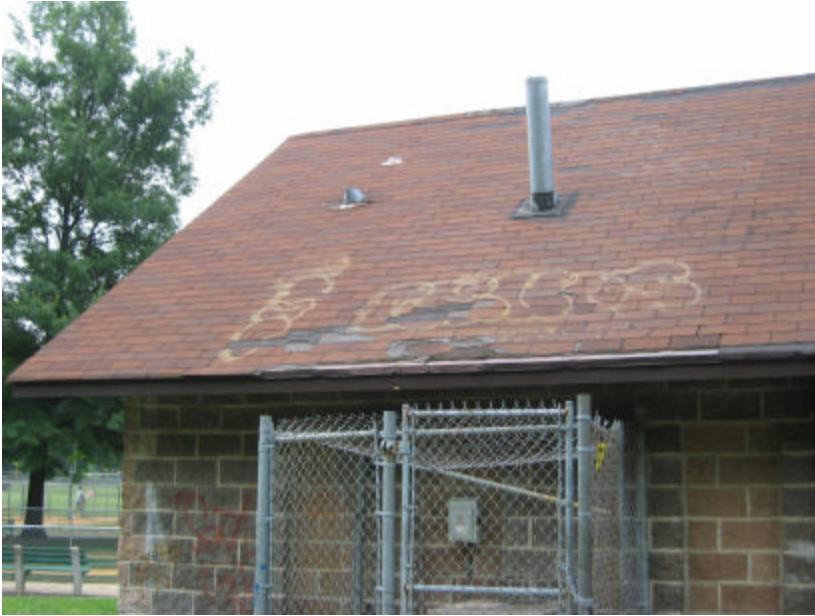
Photo 130
The north slope of the roof has missing asphalt shingles, exposed roof sheathing and graffiti along its edge.

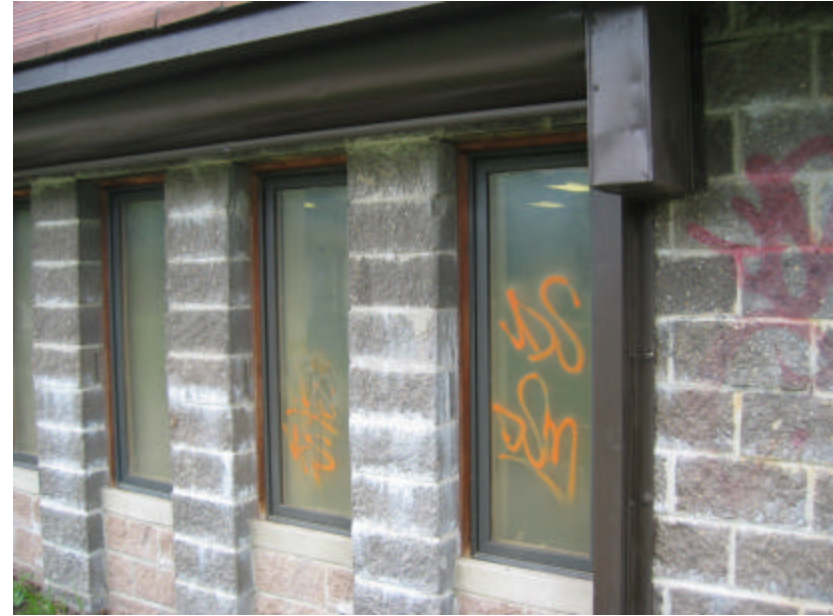
Photo 131
Three of the windows on the south façade; note the fogged plexiglas and the graffiti.

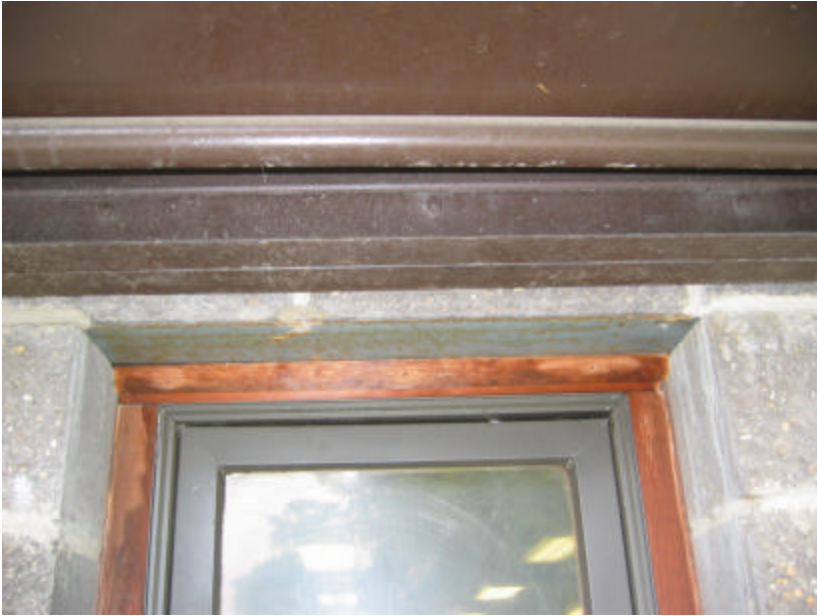
Photo 132
The rusting steel lintel spanning the window opening; note the weathering of the wood window frame.

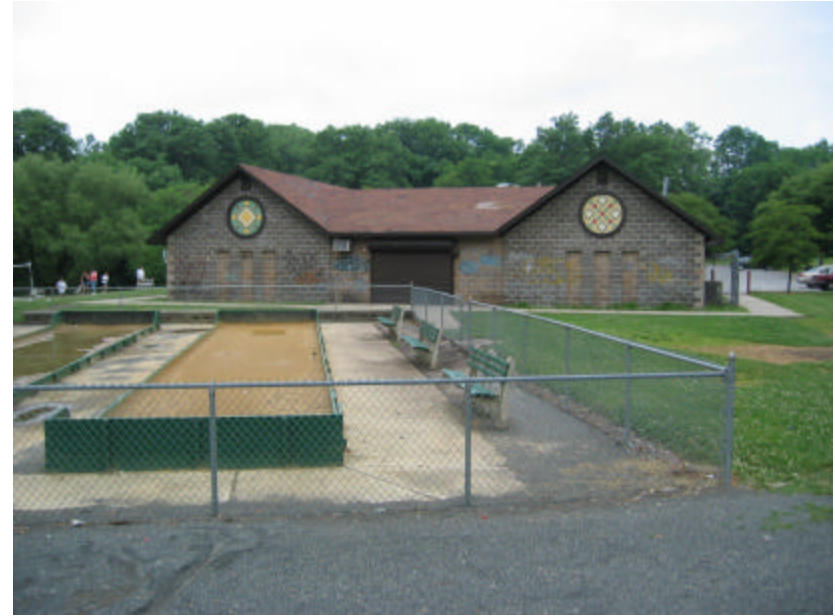
Photo 133
The bocce courts located directly east of the of the seniors' building.

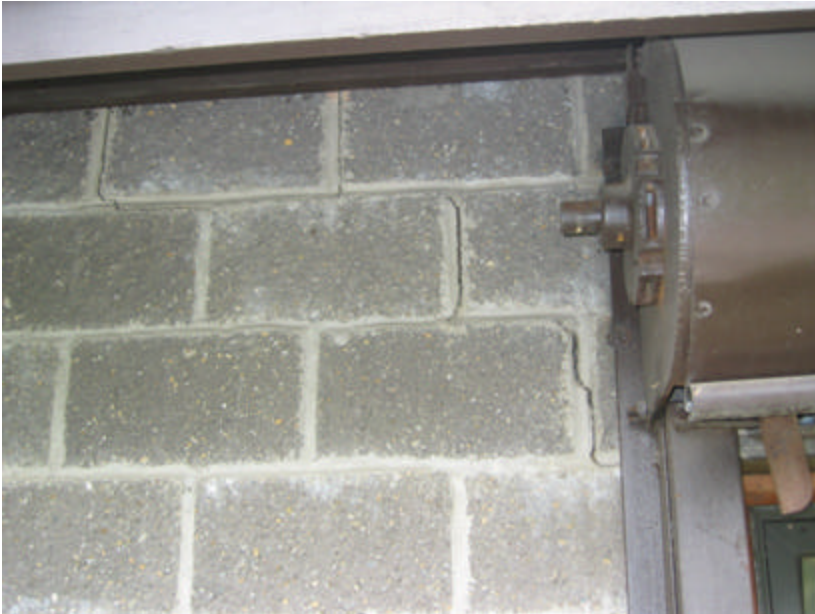
Photo 134
Zigzag cracking from the cornice to a window frame on the south façade of the building.

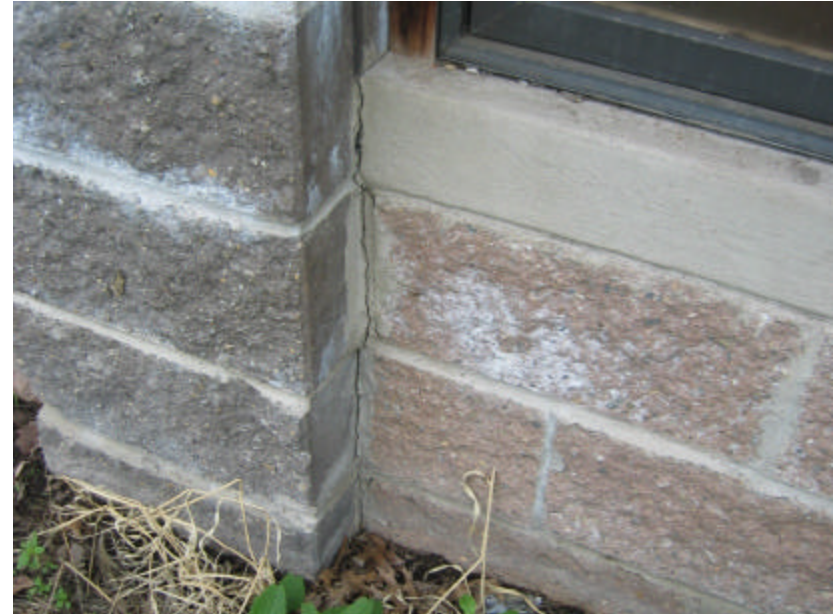
Photo 135
Vertical cracking from a windowsill to the base of the building along one of the mortar joints.

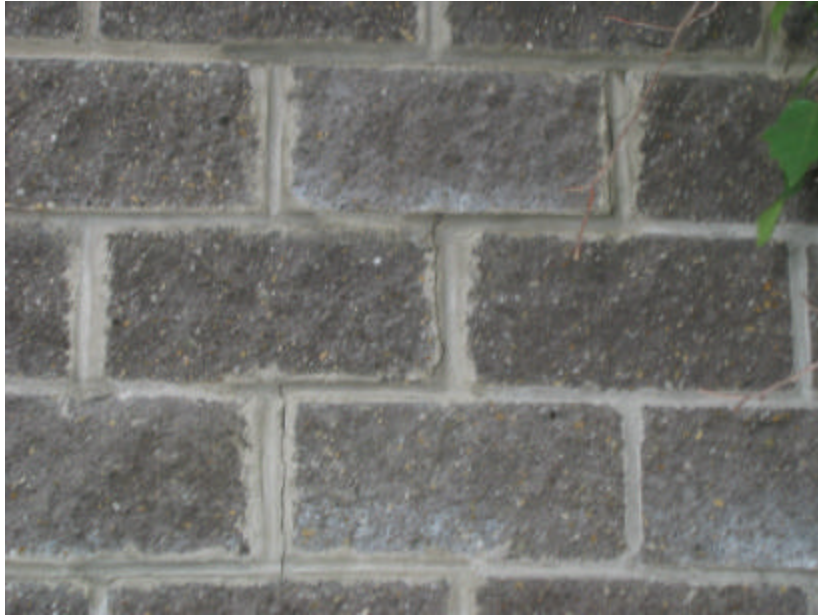
Photo 136
This zigzag crack is approximately 5' – 0" on the west façade of the seniors' building.

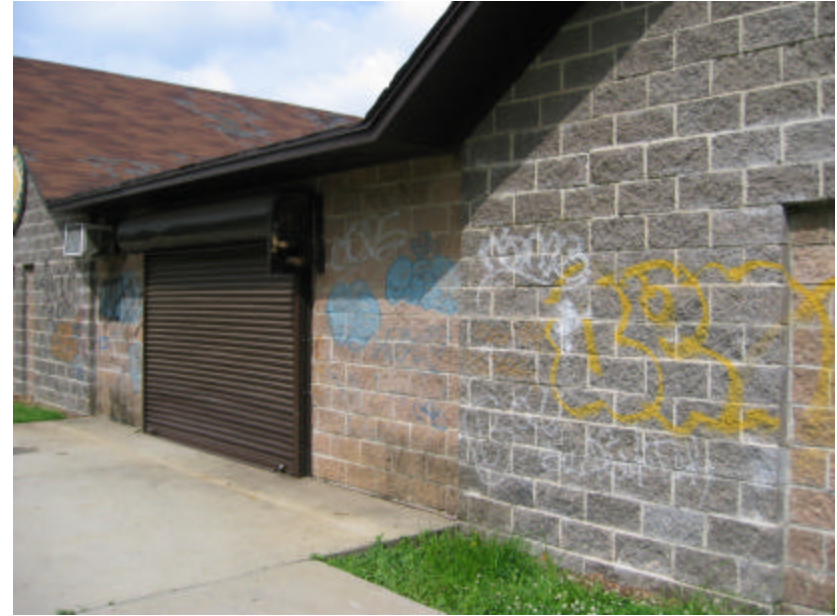
Photo 137
The east façade of the seniors' center is covered with graffiti; note the rolling steel security gates that cover the doors and windows at night.

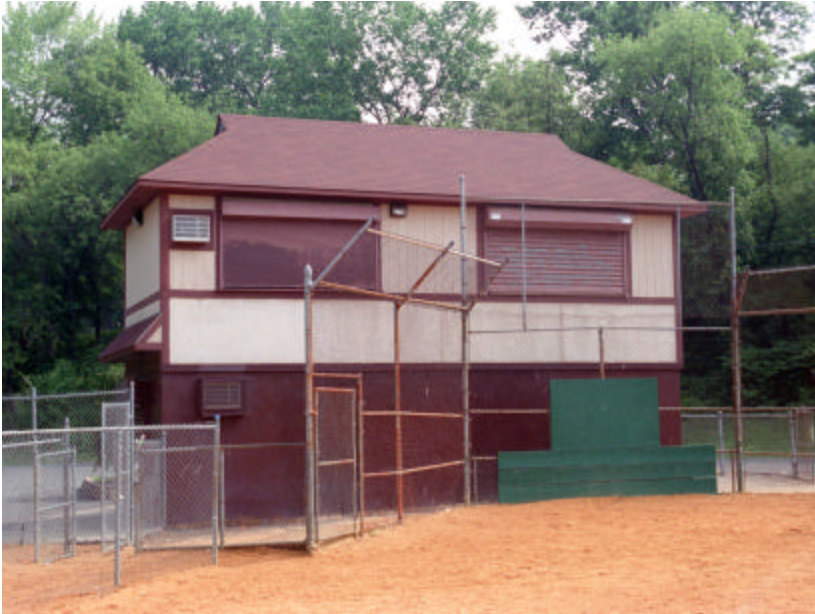
Photo 138
Overall view of the Rick Cerone field house with the press box on the second floor; note that the building is in good condition.

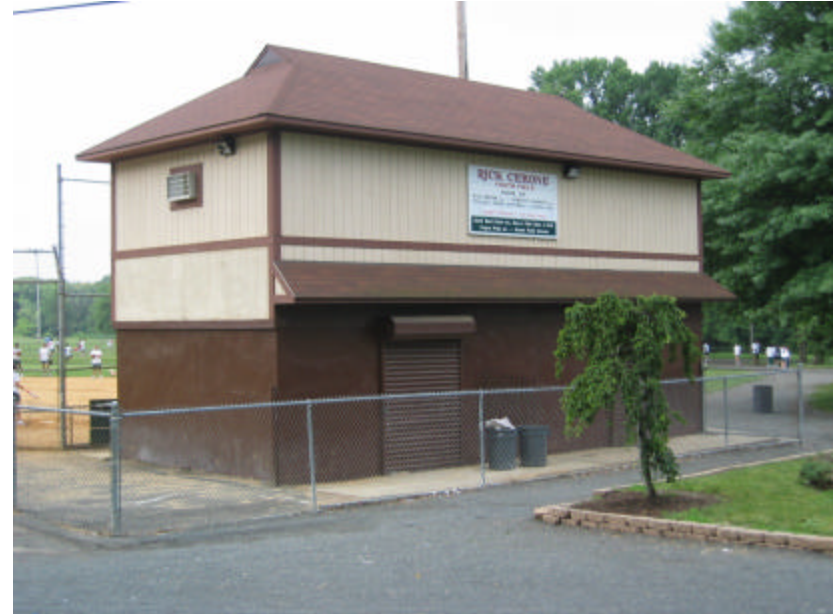
Photo 139
A view of the field house showing the different types of exterior finishes, including the smooth and rough cement finishes and the painted cedar siding and trim.

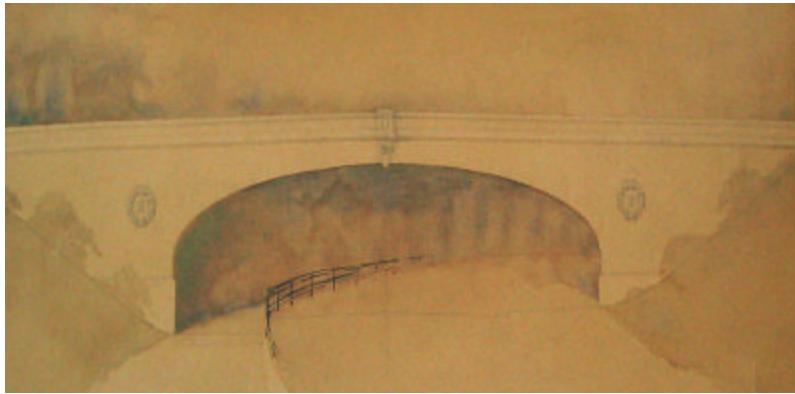
Historic Image 3
A watercolor of the Bloomfield Avenue Bridge in 1904; note how the bridge has changed over the years when compared with current photographs.

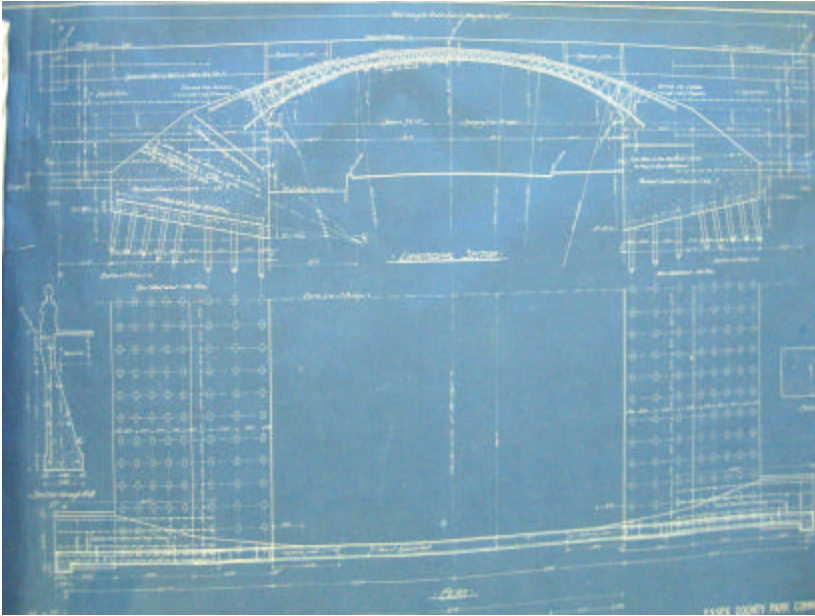
Original Drawing 20
A longitudinal section of the 1904 bridge; note the design of the foundation.

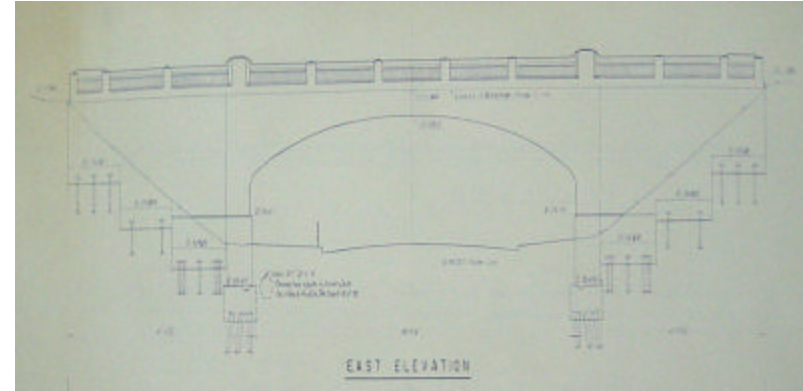
Original Drawing 21
An elevation from 1951; note how the foundations have been redesigned.

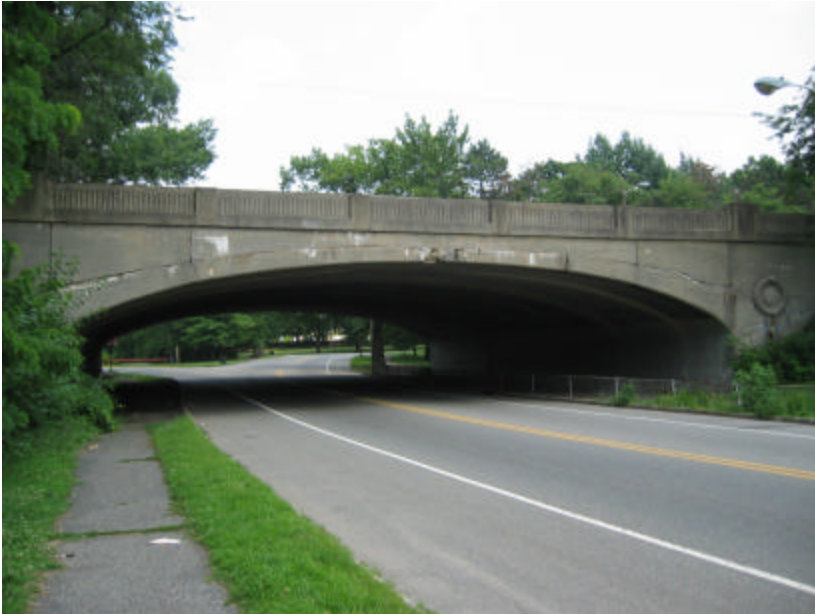
Photo 141
The Bloomfield Avenue Bridge, view from the south; note that the design of this bridge has changed over the years, compare with Original Drawing 1.

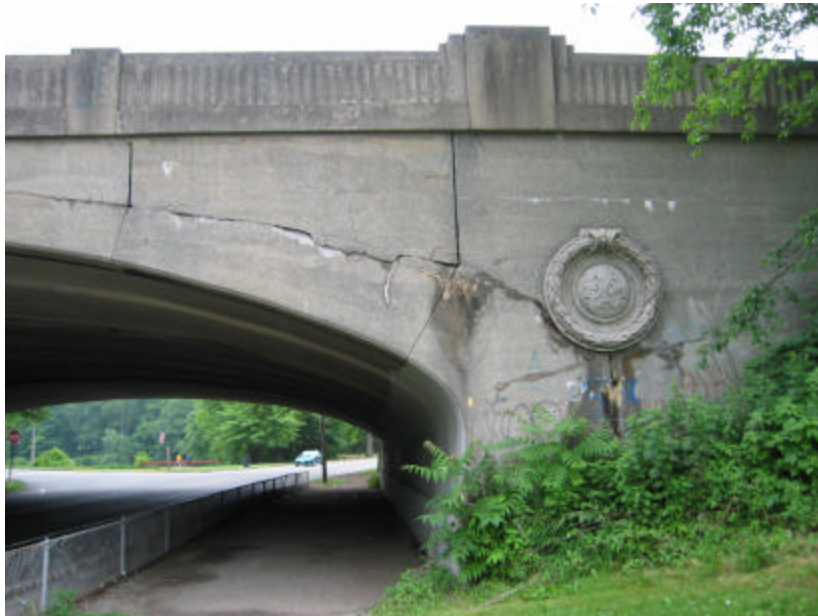
Photo 143
The south side of the bridge; note the vertical and horizontal cracking and spalling.

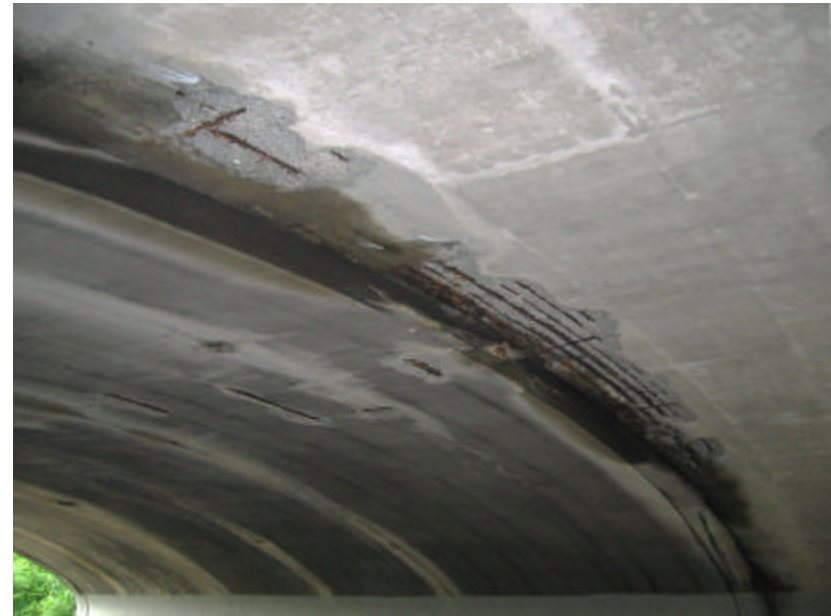
Photo 144
The underside of the bridge; note the soiled concrete and exposed, rusted steel reinforcing.

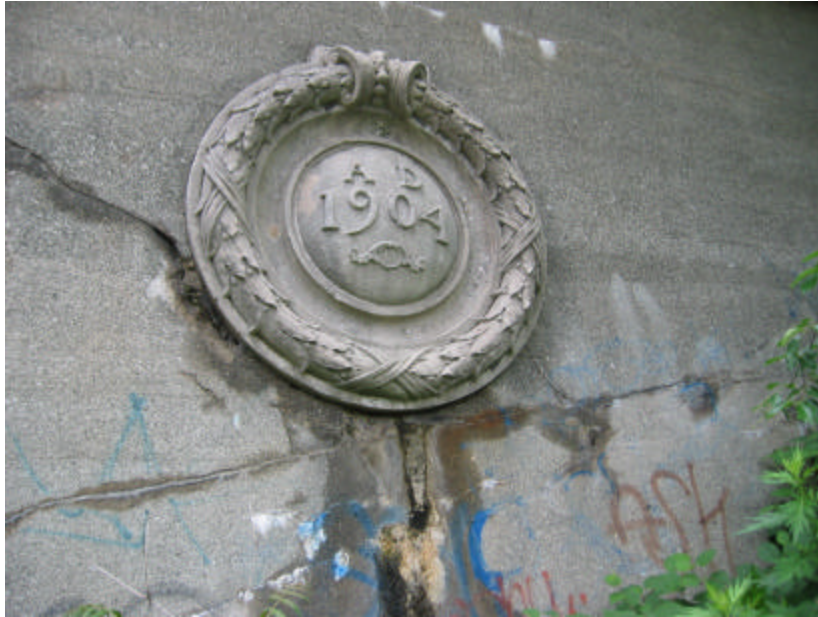
Photo 145
The medallion on the southeast side of the bridge; note the graffiti and the moisture-saturated concrete.

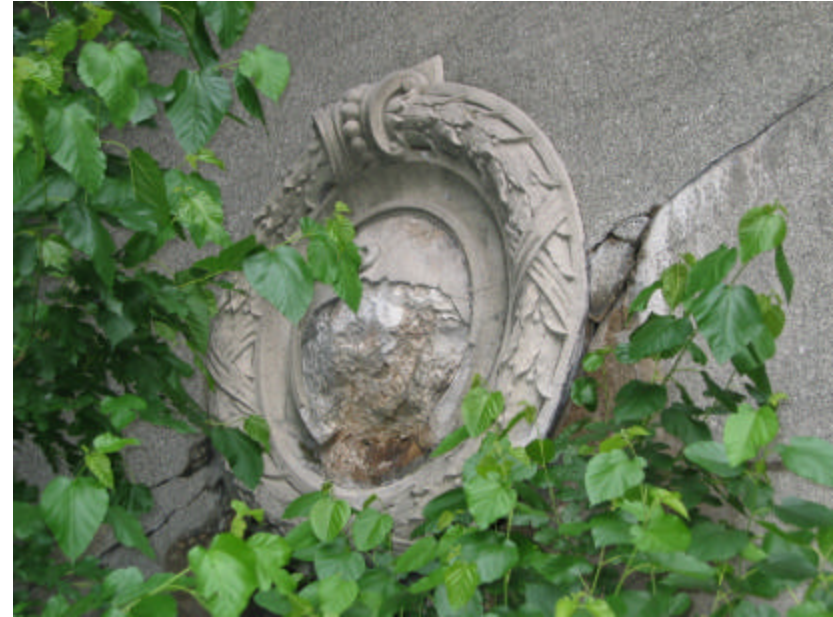
Photo 146
The medallion on the southwest side of the bridge; note that the surface has spalled and the cheek wall is cracking.

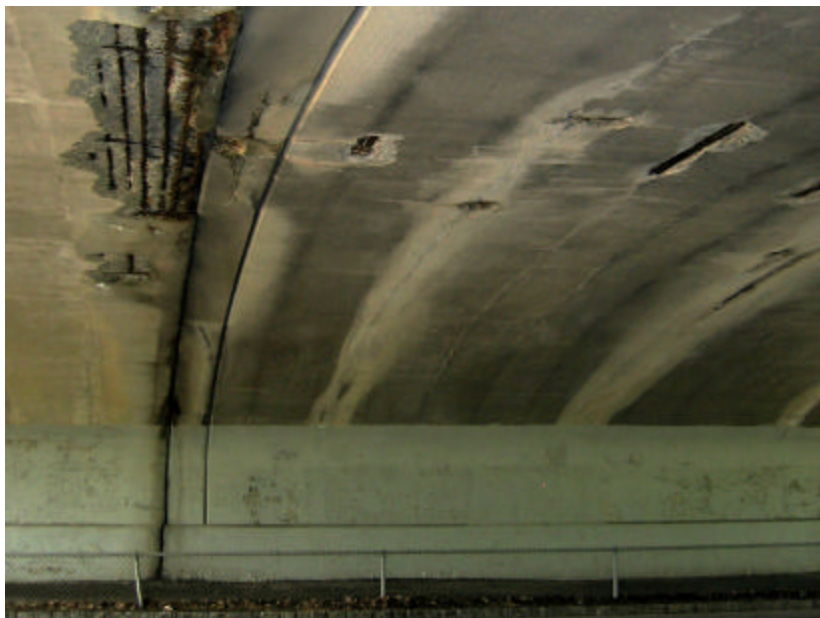
Photo 147
Extreme spalling, cracking, soiling and rusting on the underside of the bridge; note that this damage has occurred where the two arches were joined together during the 1951-1953 renovation.

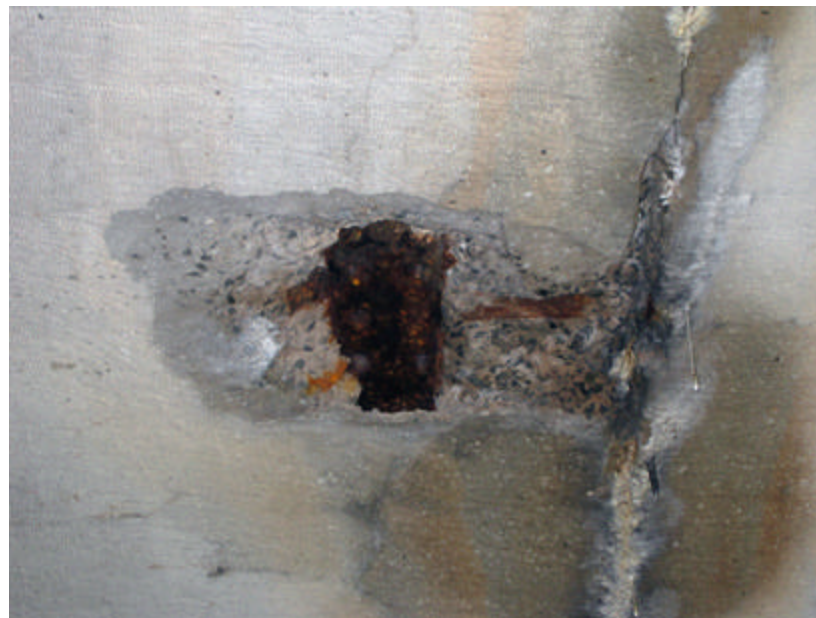
Photo 148
An area of spalling concrete and efflorescence on the underside of the bridge; note the rusted steel beam and rivets.

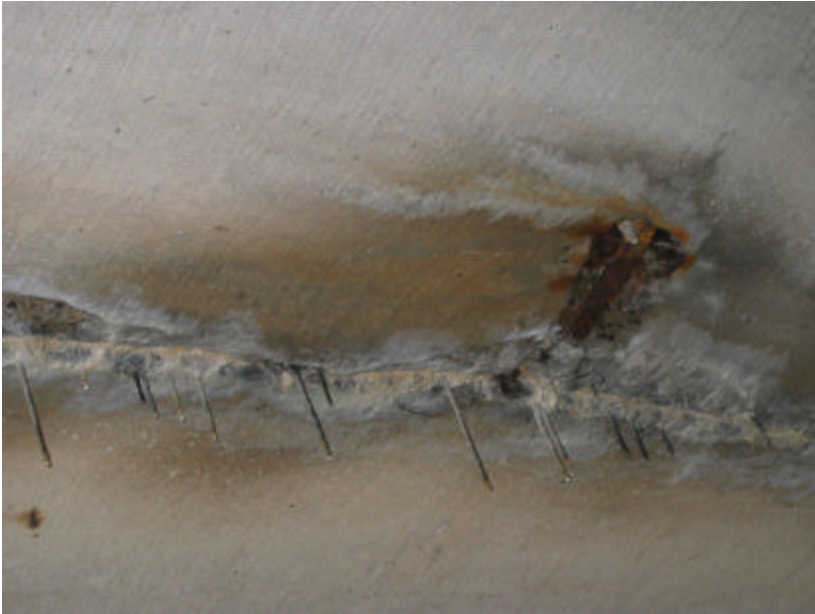
Photo 149
Efflorescence and mineral deposits forming stalactites on the underside of the bridge; note the reddish-brown discoloration caused by rusting steel.

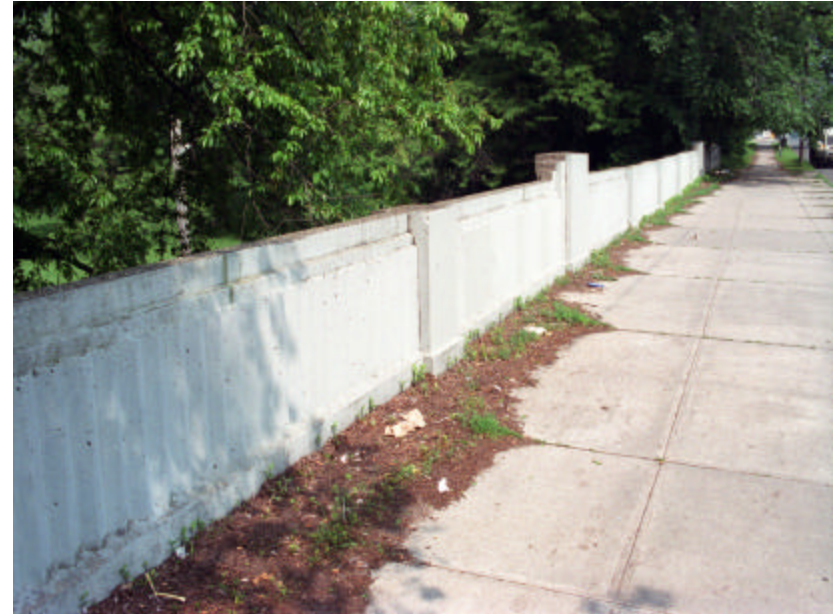
Photo 150
The south parapet wall; note the debris and vegetation along its base.

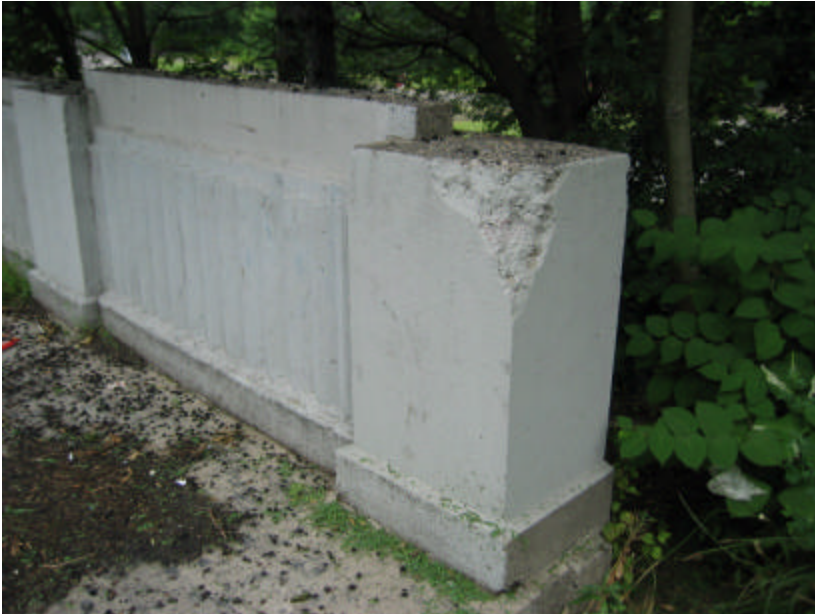
Photo 151
Spalling concrete on the end post of the north parapet wall; note that the wall has been painted to cover graffiti.

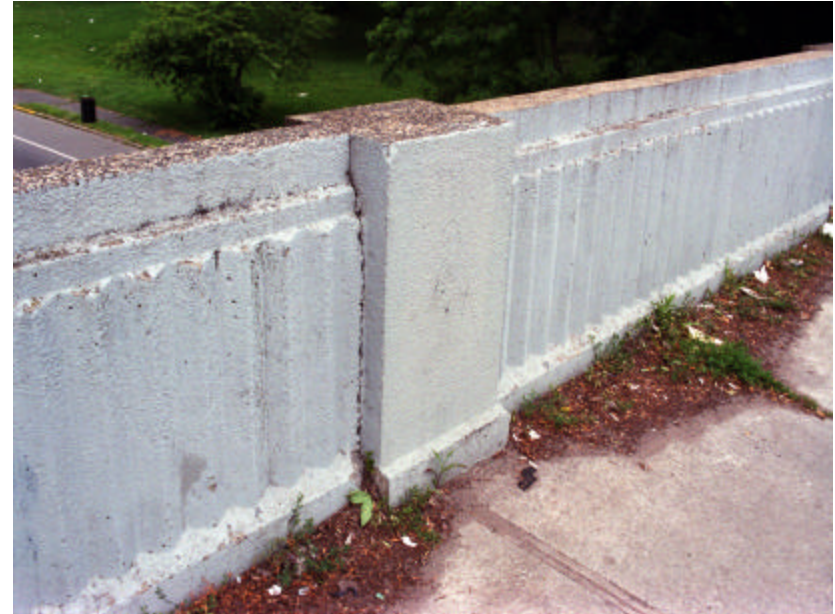
Photo 152
The soiled and painted south parapet wall; note the organic debris at its base.

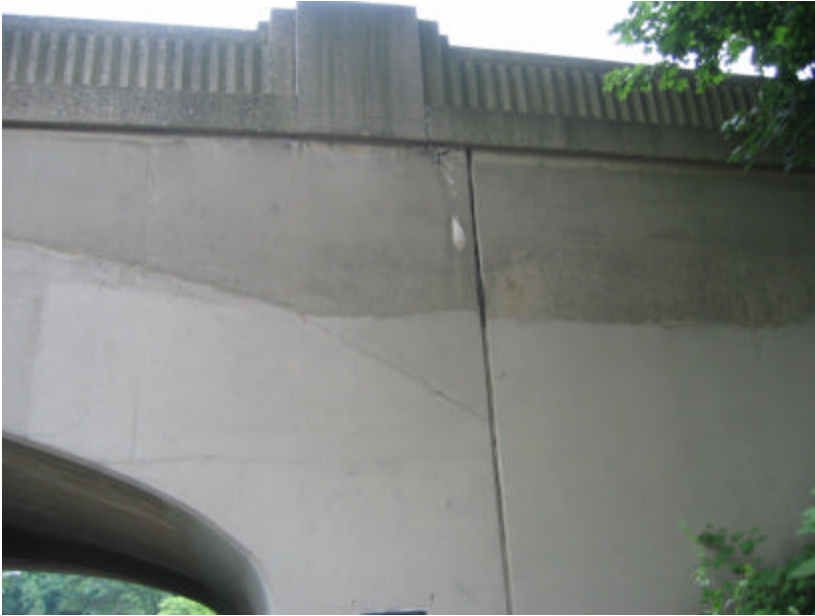
Photo 155
The north side of the bridge is in good condition but there is some cracking, spalling and soiling; note the non-matching paint.

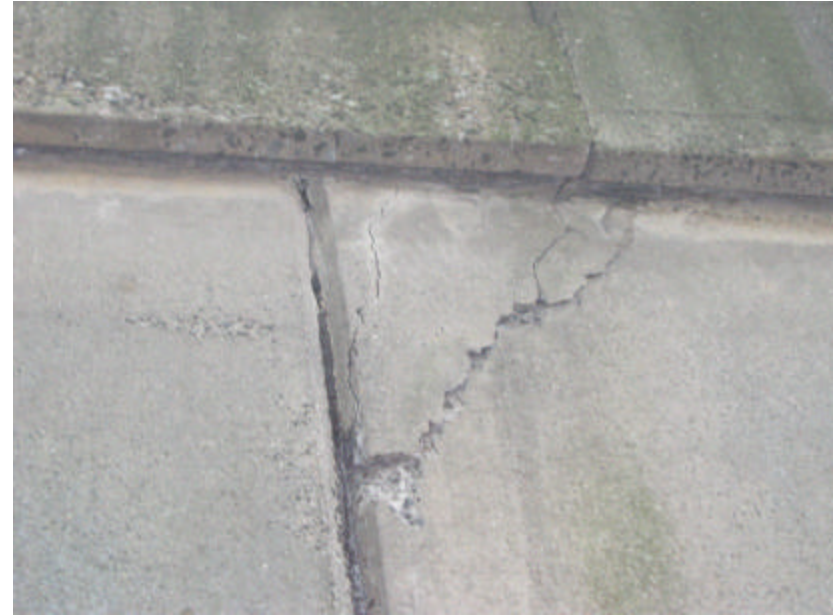
Photo 156
Concrete cracking on the north spandrel wall; note that the cracking appears below the parapet wall and next to an expansion joint.

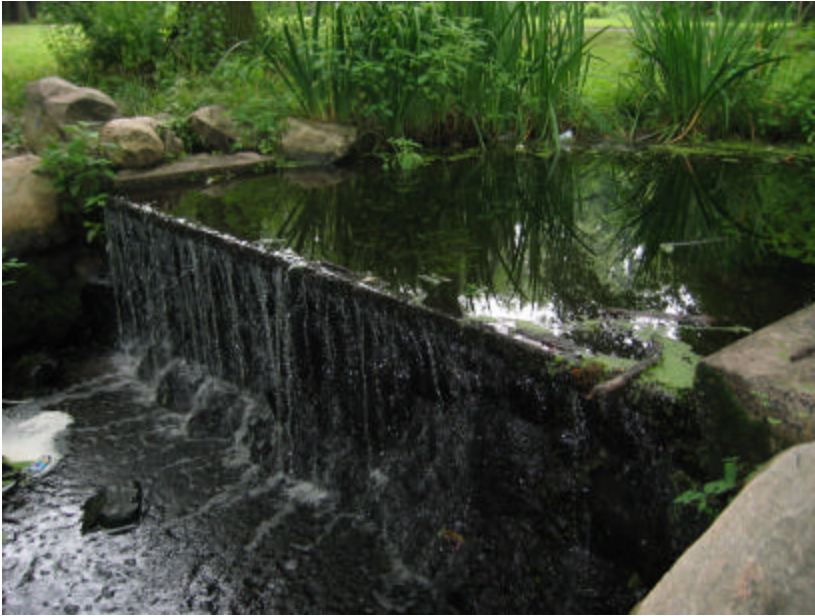
Photo 157
Weir 1 is the only weir which continues to retain a significant amount of water and which actually has water flowing over its top.

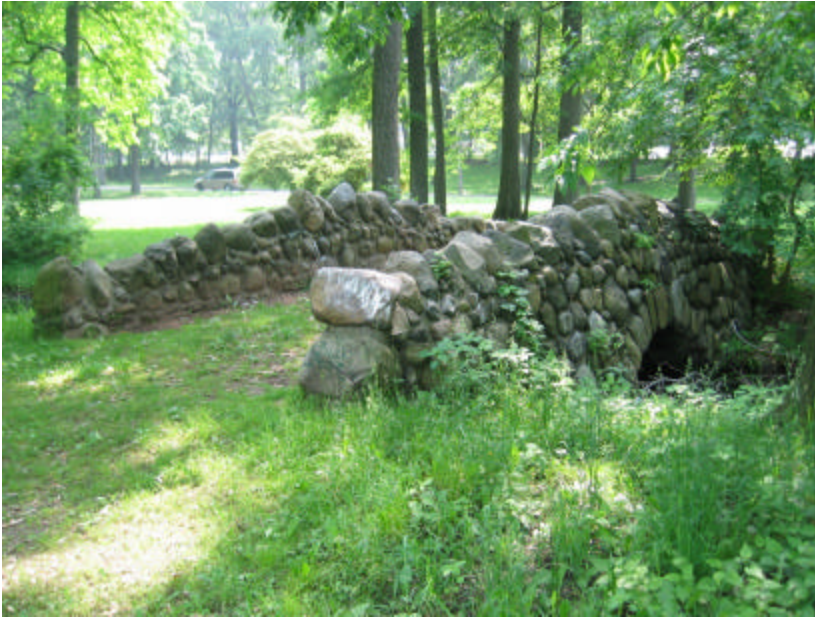
Photo 160
The Laurel Wood Boulder Bridge; note the overgrowth of vegetation around the site.

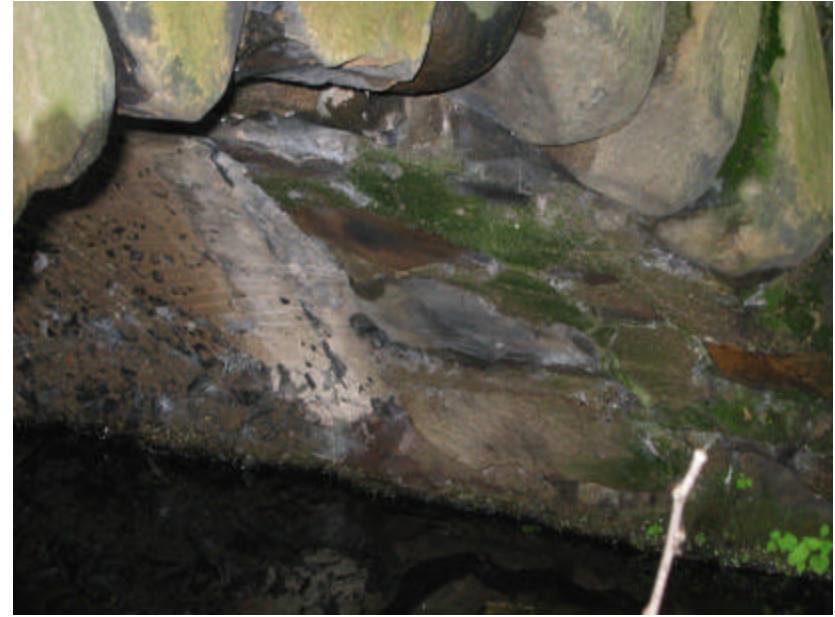
Photo 165
The underside of the fieldstone and concrete arch on the south side of the bridge; note the moss and efflorescence on the surface caused by water migration from above.

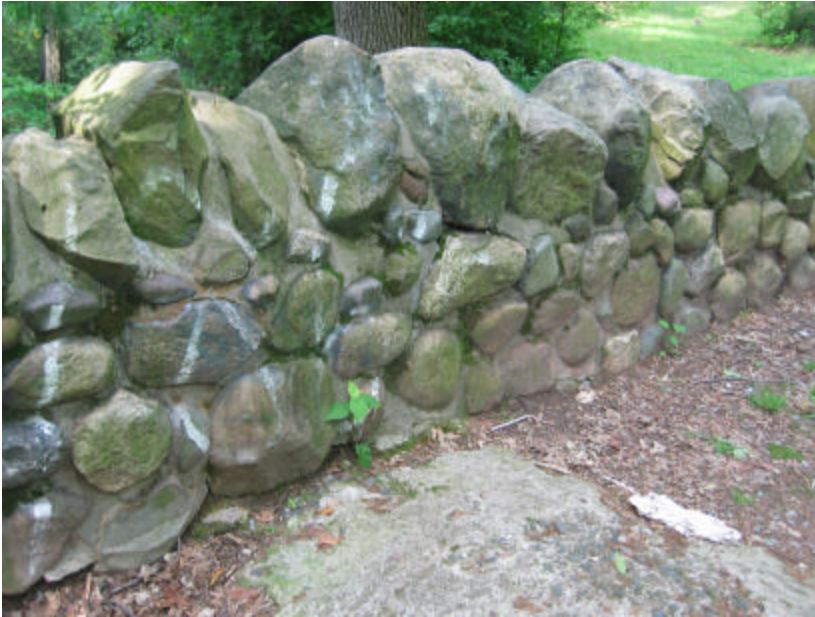
Photo 166
Open and exposed mortar joints at the base of the north cheek wall;
note the exposed and eroded top of the concrete arch.

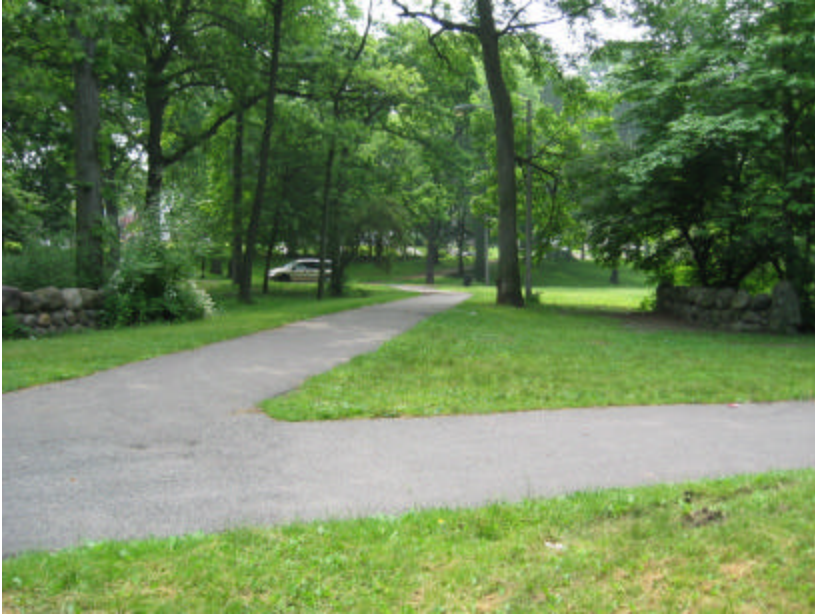
Photo 170
The Crossover Drive Bridge; note the width of bridge.

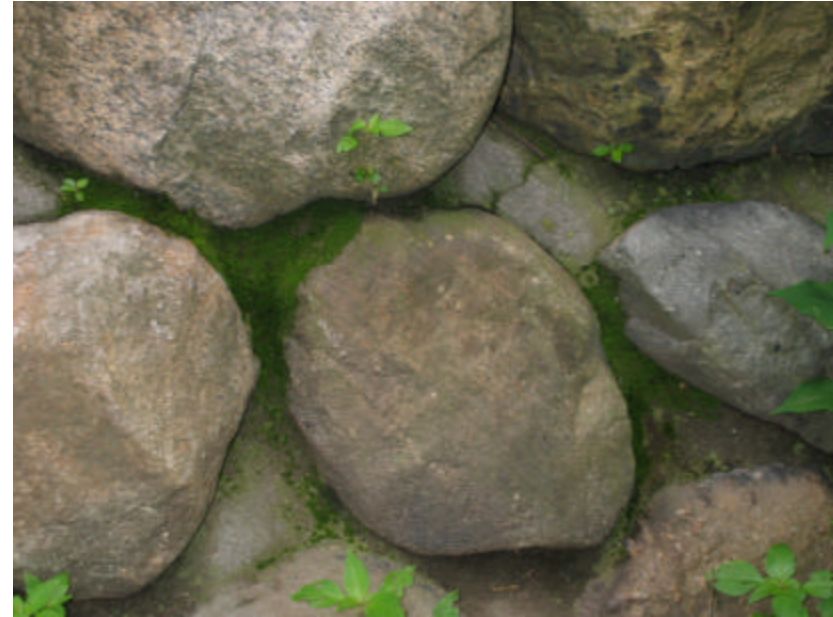
Photo 177
Organic growth including moss and weeds growing from cracks in the mortar.
