# Cultural Landscape Report, Treatment, and Management Plan for Branch Brook Park Newark, New Jersey

## Volume 3: Hydrology, Infrastructure, and Historic Fabric

14 July 2003

Rhodeside & Harwell, Incorporated  
Landscape Architecture & Planning  
320 King Street, Suite 202  
Alexandria, Virginia 22314

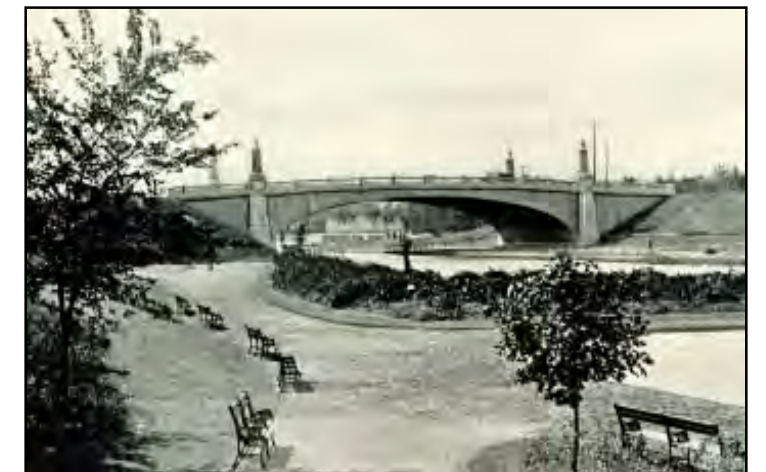
The Park Avenue [Midlake] Bridge, c.1901. Source: 1907 *Annual Report*.

Existing historic structures include the Sand Court Shelter in the southeast corner of the park, the Octagon Shelter, the Park Avenue Bridge, and the [east and west] “subway” pedestrian underpasses (one on each side of the lake). All of these structures, with the exception of the Park Avenue Bridge, were designed by the renowned architectural firm Carrere and Hastings (working in collaboration with the Olmsted firm) and were constructed between 1898 and 1900. The Park Avenue Bridge was designed by the New York architectural firm Babb, Cook, and Willard, and was constructed in 1903.

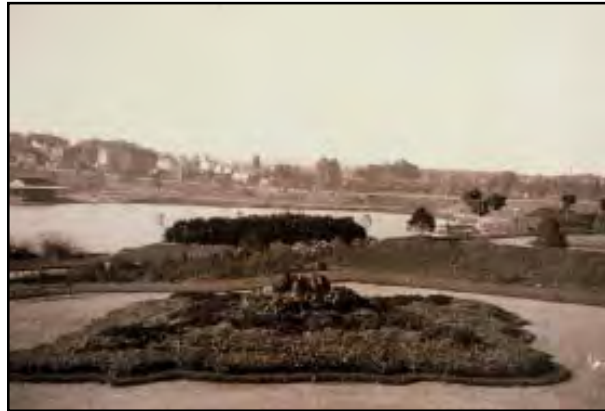
Gardens on the east side of Branch Brook Lake as they appeared in 1898, looking northwest. Source: ONHS, photo #2121-120.

A comparison between what once existed in the Southern Division (See Cultural Landscape Report Volume 2, Period Plans 5 through 8) and what remains today (Figure 1) reveals that what is seen

today on both sides of the lake are mere remnants, or apparitions, of a former glorious past. For the most part, however, those pathways, walls, and gardens that do remain can be considered contributing resources.

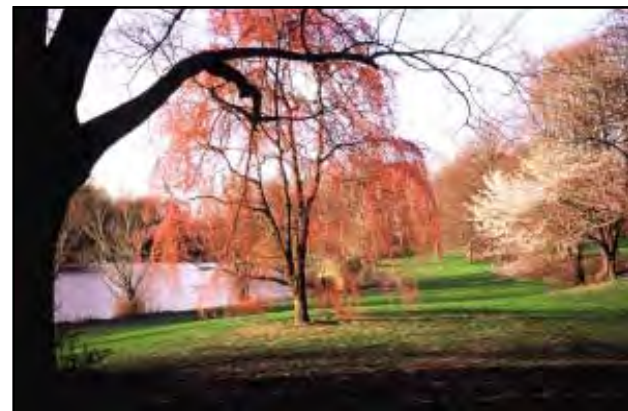
Present-day remains of formal gardens, again looking northwest across lake. Source: James Lecky.

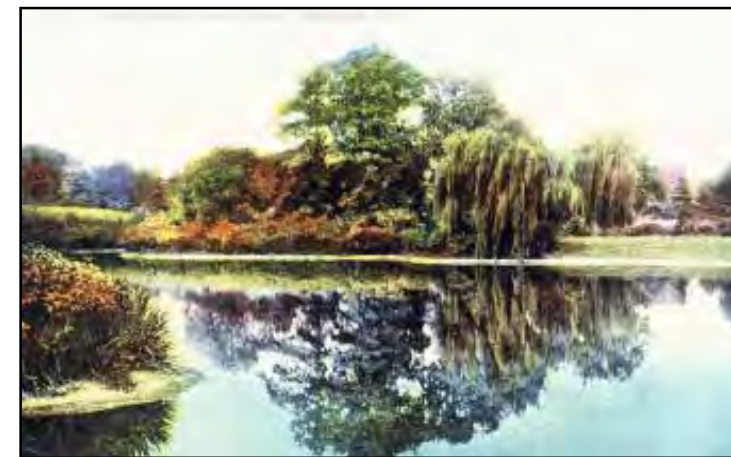
Historic view of Clark’s Island in an antique postcard, date unknown. Source: James Lecky.

Clark’s Pond Island and Abeona Pool (original features of the park – see Figure 7) no longer remain, the various parts of the water system can be considered the character-defining elements of the Northern Division and the park as a whole. These elements, along with the shoreline plantings, streamside forests, and hillsides sloping down to the water are all considered contributing resources.

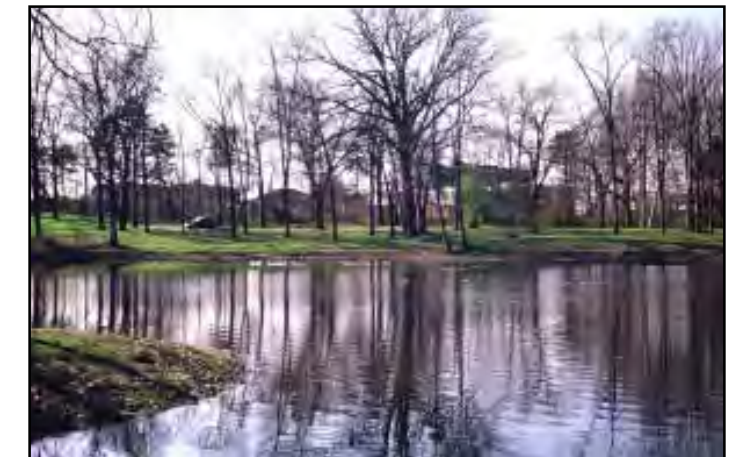
Present-day view of Clark’s Island, which is no longer separated from the shoreline. Source: James Lecky.

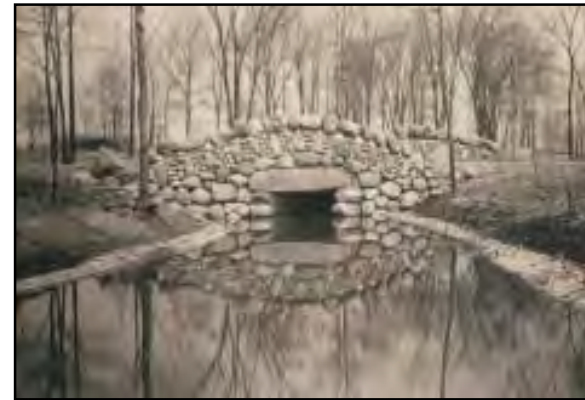
"Cobble Bridge," located between the Ballantine Gates and Abington Pool, 1901. Source: ONHS, photo #2121-73.

rough-cut granite bridges that cross over the stream between Clark's Pond and Ballantine Parkway. All of these bridges, each one slightly individual in design and character, were designed by the Olmsted firm and were constructed between 1900 and 1901. Also notable are two stone wiers (features #26 and #32 in Figure 3), which were used to control the water level in the brook. Perhaps no structure, however, is more visible and distinctive in the Northern Division than the Ballantine Gateway. This grand entrance, built with money and land donated by the Ballantine brewing family (who had been major park benefactors), was designed, like several structures in the Southern Division, by the well-known architectural firm of Carrere and Hastings.

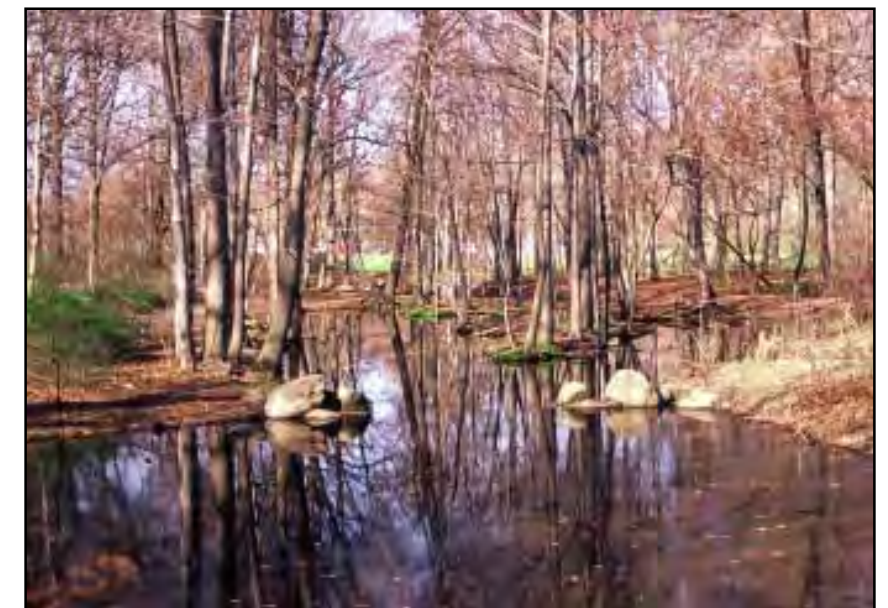
Present-day photo of wier in the Northern Division - one of three that was used to control water level in the brook. Source: James Lecky.

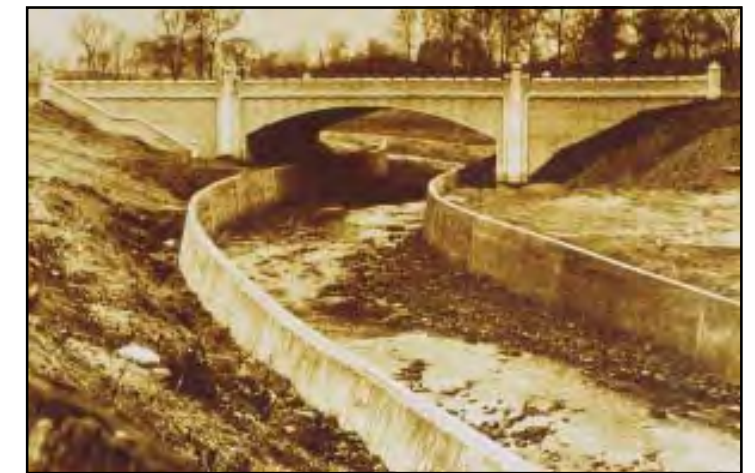
Second River channel during construction, no date. Source: Newark Public Library.

As noted in the previous section, the Second River is channelized with a series of planted terrace walls along the entire length of the Extension. This improvement was part of the original design, and allowed designers the space to create a scenic parkway along the top of the river bank. Figures 5 and 6 also note the type of bottom material along the length of the river in the Extension, as it varies between natural stone, cobble stone, and concrete.

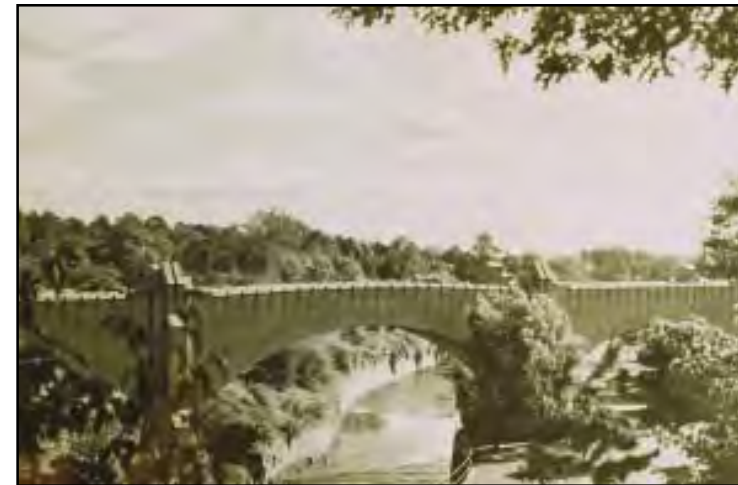
Pedestrian bridge over Second River, date unknown. Source: Newark Public Library.

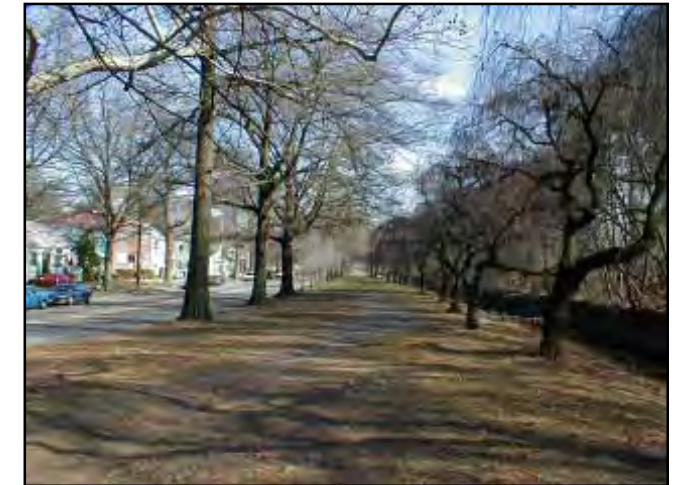
Present-day view of the Extension's eastern end, with the Second River and cherry trees to the right.

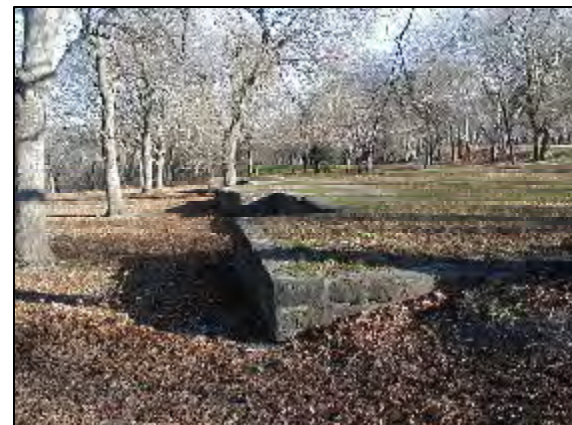
Existing remains of the “Dutch Garden” in the Southern Division.

original design. On the west side of the lake in the Southern Division, the “Music Court” is missing its main concourse, bandstand, radial system of paths, and many of its formal tree plantings, while on the east side of the lake almost all of the original paths and gardens are missing. One entire block of this area (between Parker Street and Highland Street) was, in fact, destroyed when the existing Barringer High School was built in 1961 on [what was then] park land. Other areas in the Southern Division that have been severely compromised include the Statuary Garden, the area around the Dutch Garden, the pathways and arbor between the Reservoir and Clifton Avenue, and the Reservoir itself. Also missing are the original boathouse and many of the features of the “Boys’ Park” located south of Interstate 280 and Orange Street.

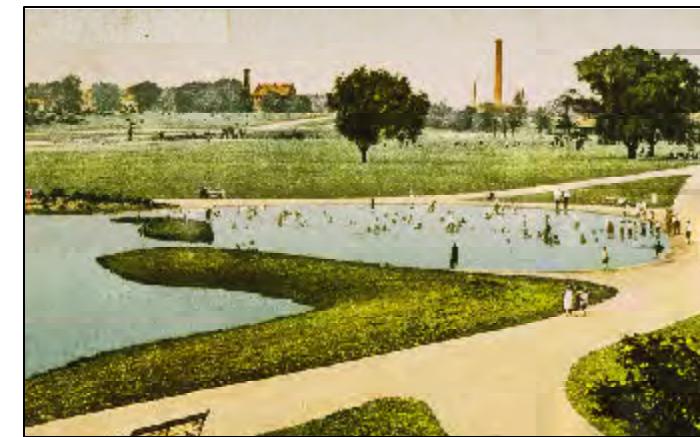
Postcard showing the Wading Pool in the Middle Division, with the Playfield visible in the background, 1905. Source: Newark Public Library.

In the Middle and Northern Divisions, a number of pools and channels that were part of the original watercourse design are missing. Consequently, the physical and spatial integrity of these spaces has been compromised or destroyed. Included are the Wading Pool and the northern end of the lake in the Middle Division, and the Abeona Pool and the channel separating Clark’s Pond Island in the Northern Division.

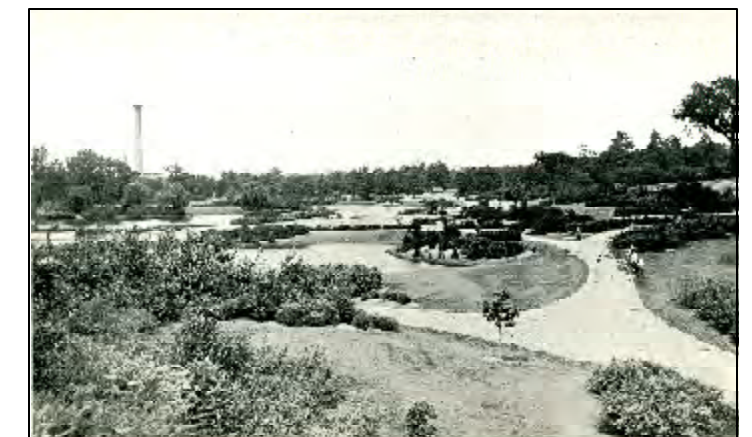
Looking northwest across Abeona Pool to Clark’s Pond in the Northern Division, 1901. Source: 1901 Annual Report.

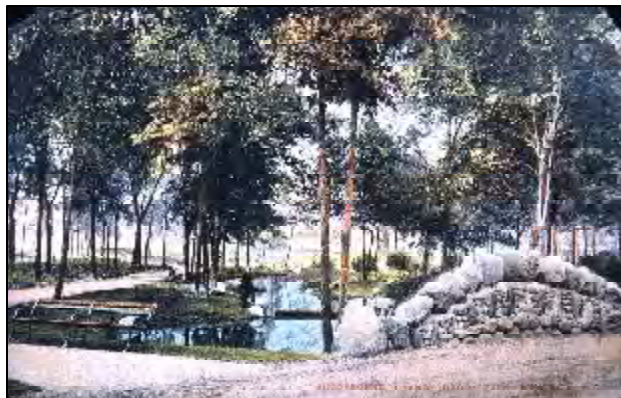
Historic postcard showing the Midwood Pool Bridge in the Northern Division, date unknown. Source: James Lecky.
